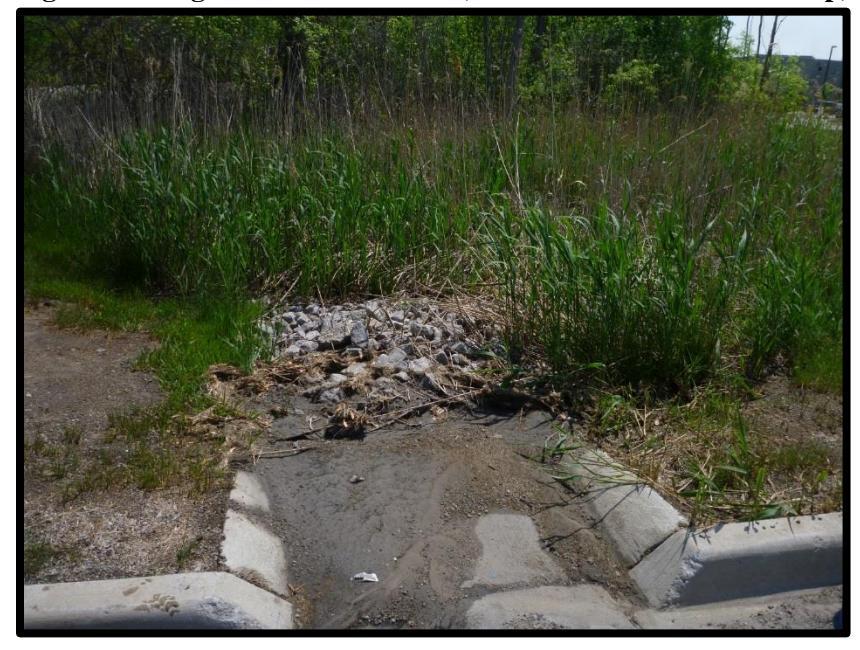
Figure 2.Phragmites near bioswale (Location #5 on reference map)

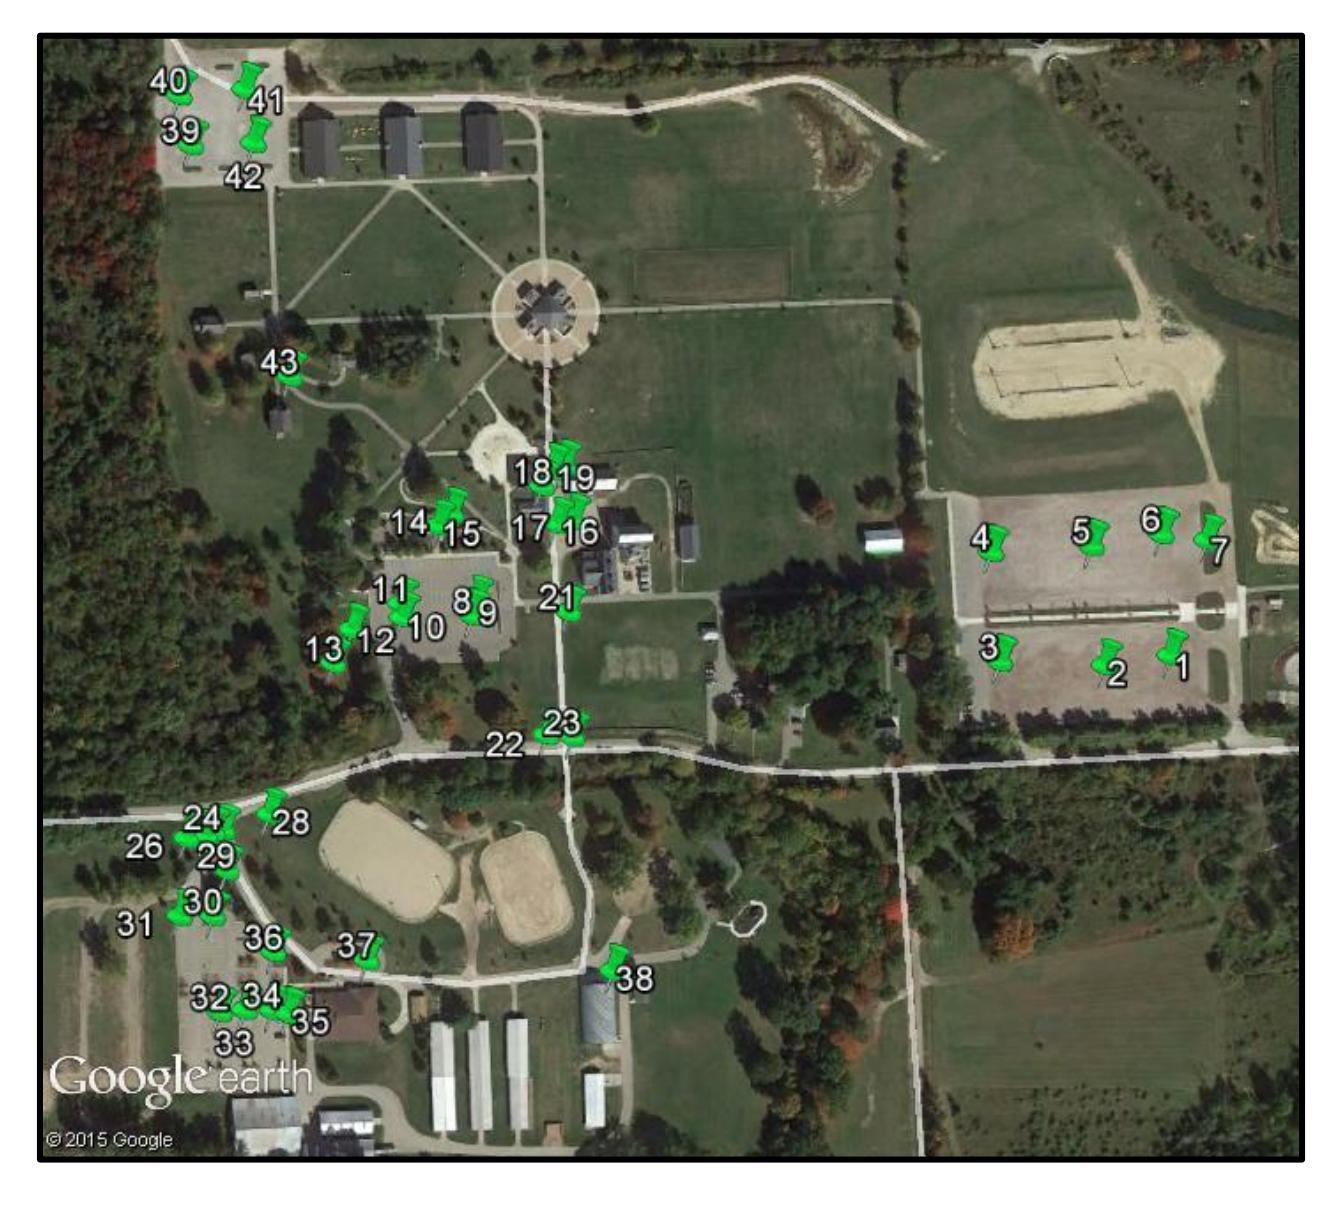
Figure 1.Reference Map

7	42.984079	-82.652967	Sediment: Too deep to measure, approximately 1" to 2" sediment—	Low
			monitor and re-check in 2017	
			Water: Standing water present	
0	42.0027	92 (5901	Structure: Good condition	T
8	42.9837	-82.65801	Sediment: 100 deep to measure, approximately 1 to 2 sediment—	Low
			Weter: Standing water present	
0	42 09277	82 65700	Sadimente 1" to 2" acdimente monitor and re shack in 2017	Low
9	42.98577	-82.03799	Structure: Good condition	LOW
10	42.98369	-82.65849	Sediment: Too deep to measure, approximately 1" to 2" sediment—	Low
			monitor and re-check in 2017	
			Water: Standing water present	
			Structure: Good condition	
11	42.98376	-82.6585	Sediment: 2" to 3" sediment—monitor and re-check in 2017	Low
			Water: Standing water present	
			Structure: Good condition	
12	42.98363	-82.65884	Sediment: Too deep to measure—monitor and re-check in 2017	Low
			Water: Flow present	
10	12 00246	00 (5000	Structure: Good condition	TT' 1

13	42.98346	-82.65898	Sequence: 100 deep to measure—monitor and re-check in 2017 Structure: Damaged grate needs repair. Good condition on interior	High
			Suructure: Damaged grate-needs repair. Good condition on interior	
14	42.98421	-82.65815	Other: Inactive/dormant. Full of dirt and leaves.	Low
15	42.98415	-82.65824	Sediment: 1" to 2" sediment—monitor and re-check in 2017	Low
			Water: Standing water present	
16	42.98416	-82.65743	Sediment: 2" to 3" sediment—monitor and re-check in 2017	Low
			Water: Standing water present	
			Structure: Good condition

17	42.98418	-82.65732	Sediment: Approximately 2" sediment (gravel) —monitor and re- check in 2017 Water: Dry Structure: Good condition	Low
18	42.98435	-82.65753	Sediment: 4" to 5" sediment—monitor and re-check in 2017 Water: Standing water present	Low
19	42.98443	-82.65746	Sediment: 1" to 2" sediment and rock—monitor and re-check in 2017 Water: Standing water present, chlorine odor – monitor and verify potential connection to fountain drains Structure: Good condition	Medium
20	42.98445	-82.65738	Sediment: Approximately 6" sediment— removal of sediment recommended Water: Standing water present, chlorine odor—monitor and verify potential connection to fountain drains	Medium
21	42.98372	-82.65735	 Sediment: Approximately 2" sediment and rock—monitor and recheck in 2017 Water: Standing water present Structure: Good condition Other: Vegetation around grate—remove vegetation. Potential for erosionmonitor 	Medium

22	42.9831	-82.65751	Sediment: Too deep to measure—monitor and re-check in 2017 Structure: Good condition	Low
23	42.98309	-82.65733	Sediment: Too deep to measure, approximately 1" to 2" sediment— monitor and re-check in 2017 Other: Vegetation around grate—remove vegetation	Low
24	42.98261	-82.65981	Sediment: 2" to 3" sediment—monitor and re-check in 2017 Structure: Good condition	Low
25	42.98259	-82.65986	Sediment: 1" to 2" sediment—monitor and re-check in 2017 Structure: Good condition	Low
26	42.98258	-82.65999	Sediment: Approximately 1" sediment—monitor and re-check in 2017 Structure: Good condition	Low
27	42.98262	-82.65974	Sediment: 2" to 3" sediment—monitor and re-check in 2017 Structure: Good condition	Low
28	42.9827	-82.65942	Sediment: 1" sediment—monitor and re-check in 2017 Structure: Good condition	Low
29	42.98242	-82.65971	Sediment: 1" to 2" sediment—monitor and re-check in 2017 Water: Standing water present Other: Debris present—remove debris on grate	Low

30	42.98219	-82.6598	Sediment: 1" to 2" sediment—monitor and re-check in 2017 Structure: Good condition	Low
31	42.98219	-82.66003	Sediment: 2" to 3" sediment—monitor and re-check in 2017 Structure: Minor seepage on north side of interiormonitor Other: Debris present—remove debris on grate	Medium
32	42.98171	-82.65975	Sediment: 1" to 2" sediment—monitor and re-check in 2017 Water: Minor turbidity (cloudiness)monitor	Medium
33	42.98172	-82.65958	Sediment: Approximately 1" sediment—monitor and re-check in 2017 Structure: Good condition	Low

34	42.98172	-82.65939	Sediment: Too deep to measure—monitor and re-check in 2017	Low
			Water: Standing water present	
			Structure: Good condition	
35	42.9817	-82.65928	Sediment: 3" to 4" sediment—monitor and re-check in 2017	Low
36	42.98201	-82.65938	Sediment: Too deep to measure, approximately 2" to 3" sediment— monitor and re-check in 2017. Minor/small rocks present in catch basin	Low
37	42.98197	-82.65874	 Sediment: Too deep to measure, approximately 2" to 3" sediment—monitor and re-check in 2017. Water: Minor turbidity (cloudiness)monitor Structure: Minor concrete crackingmonitor 	Medium
38	42.98191	-82.65706	Other: Minor debris present at bottom of structure	Low
39	42.98606	-82.65994	Sediment: 1" to 2" sediment (rock) —monitor and re-check in 2017	Low
40	42.98631	-82.66002	Sediment: 1" to 2" sediment (rock) —monitor and re-check in 2017	Low
41	42.98634	-82.65957	Sediment: 3" to 4" sediment—monitor and re-check in 2017	Low

42	42.98607	-82.65951	Structure: Good condition Other: Some debris and vegetation present around exterior—remove debris and vegetation.	Low
43	42.9849	-82.65926	Other: Small structure, possibly sump to house. Grates too small to measure—monitor and re-check in 2017	Low

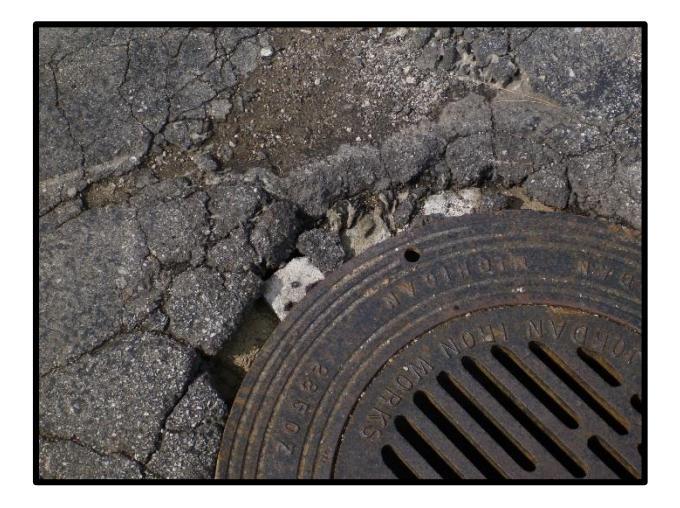
Figure 2.Catch Basin #1

Number on Map	Latitude	Longitude	Inspection Notes/Maintenance Required	Priority
1	42.98002	-82.421	Sediment: Approximately 1" sediment—monitor and re-check in 2017Water: Standing water presentStructure: Cracked asphalt around structuremonitor	Medium
2	42.98001	-82.4214	Sediment: Approximately 1" sediment—monitor and re-check in 2017Water: Standing water presentStructure: Good condition	Low
3	42.97996	-82.4218	Sediment: 2" to 3" sediment—monitor and re-check in 2017 Water: Standing water present	Low
4	42.97981	-82.4216	Sediment: 1" to 2" sediment—monitor and re-check in 2017 Water: Standing water present	Low
5	42.97981	-82.4212	Sediment: 2" to 3" sediment—monitor and re-check in 2017 Water: Standing water present	Low
6	42.9798	-82.4209	Sediment: 1" to 2" sediment—monitor and re-check in 2017	Low
7	42.97983	-82.4207	Sediment: No sediment Water: Standing water present	Low
8	42.97966	-82.4207	Sediment: No sediment Water: Standing water present	Low
