Mudge Log Cabin (1863)

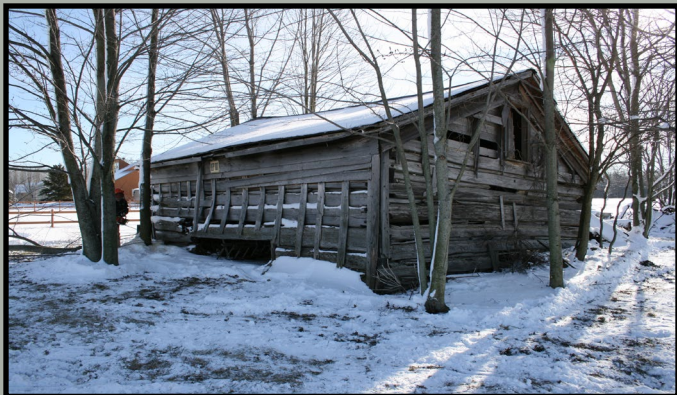
The cabin before it was dismantled.

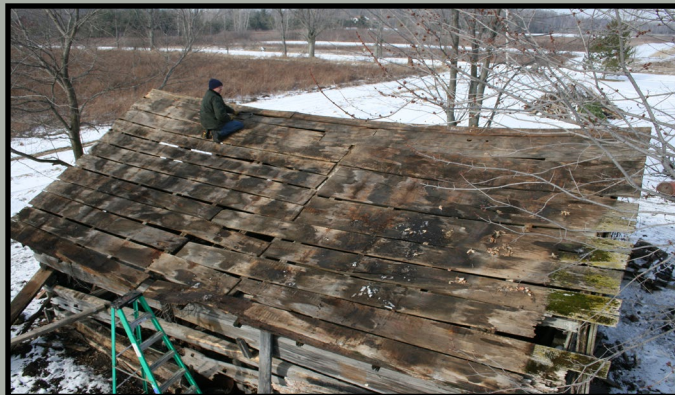
Staff works to remove roof boards. Most of the boards were salvaged and repaired.

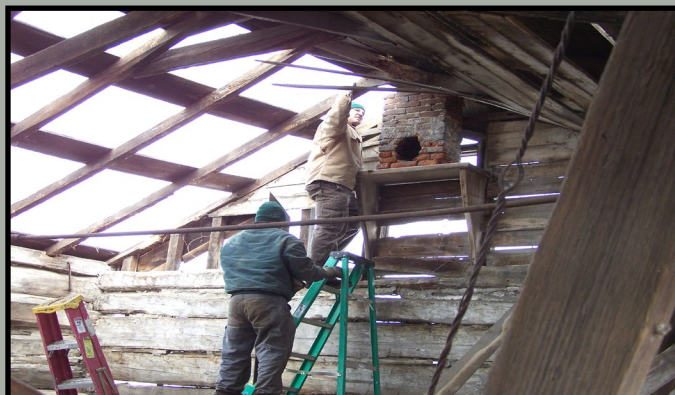
Staff carefully removes the original brick chimney. The unique chimney sat on a wood platform.

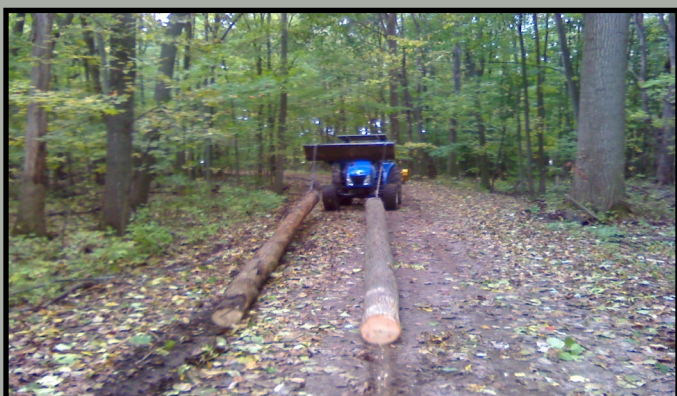
To replace rotted cabin logs, park staff selectively cut park Ash trees lost to the Ash Borer.

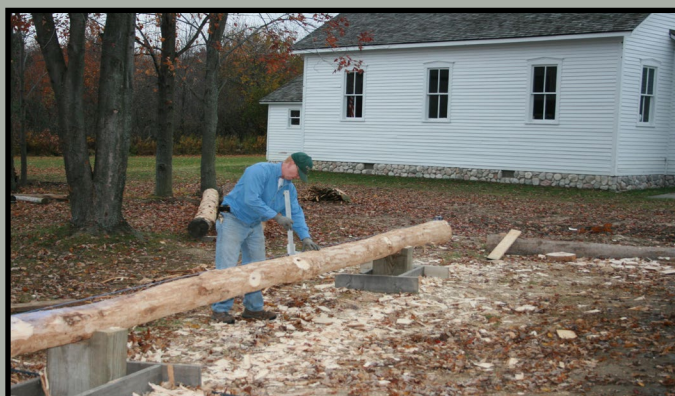
Park staff was trained to hand hew the logs for the cabin. This included using a broad axe and an adze.

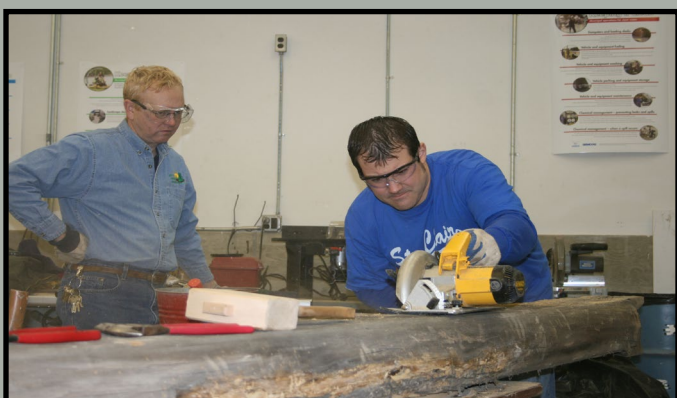
Some cabin logs needed some repair. Staff used a special epoxy to fill the rotted areas.

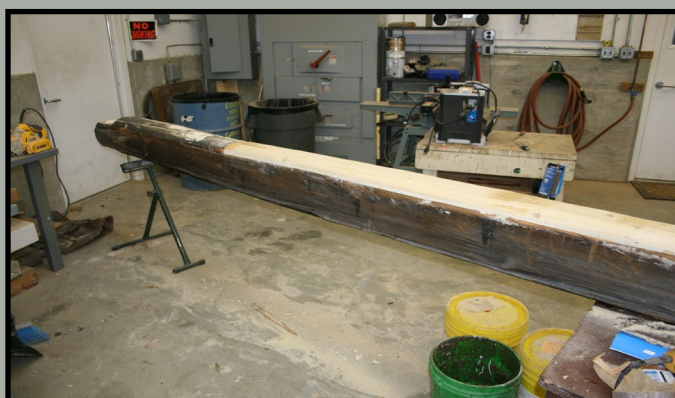
This log had a rotted top but was salvageable. It was repaired using a cap that was reshaped to match.

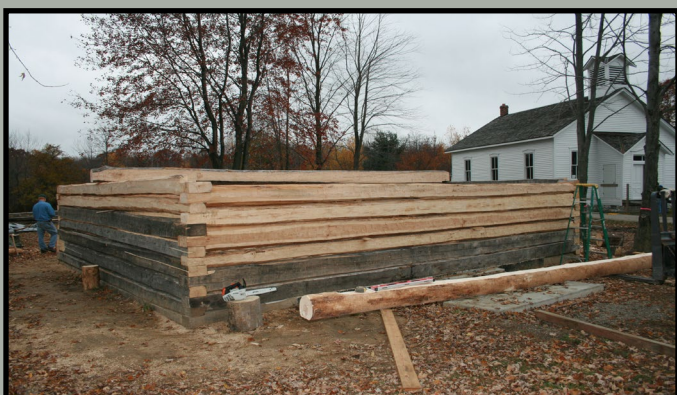
The cabin being reassembled, using original and replacement logs.

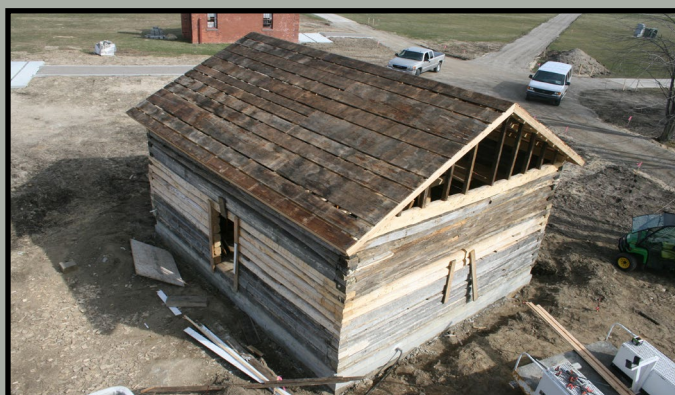
The roof boards after being reinstalled. These can be seen in the before photo at the top of the page.
