CHAPTER 2 – WATER QUALITY CONDITIONS

2.1 Water Quality

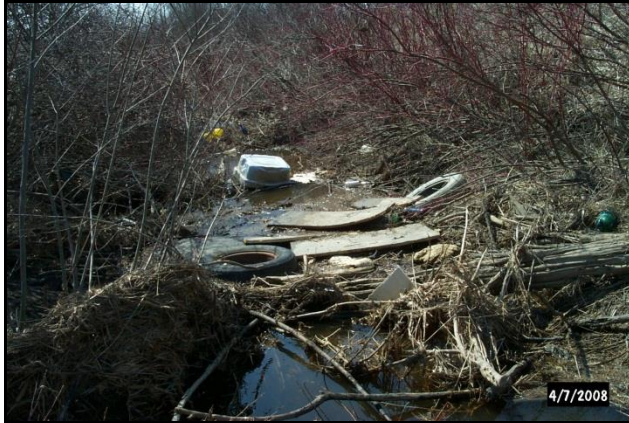
Figure 2.7 Debris in Currier Drain (Berlin Twp., Burt Rd.)

Large-item trash collection and recycling has been eliminated in many municipalities due to budget cuts, and fees are often collected for disposal of large waste, such as tires. Incidents of dumping of large trash items such as tires and appliances in the Belle River appear to be increasing in recent years (Figure 2.7 and 2.8). Existing data is limited and is mostly based on Drain Office reports, County Park staff, and public input. For example, an estimated 50 tires were noted in the Belle River during field inventories between Kronner Road and Gratiot Ave in Columbus Township. Currently, no formal list exists for possible Belle River clean-up sites, but during the watershed inventory several sites were identified that could be used to start a prioritized list for clean-up events.

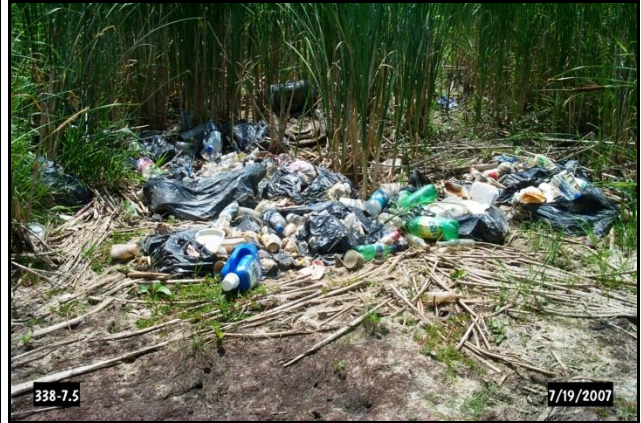
Figure 2.8 Trash in Hannah Drain (Berlin Twp., Burt Rd.)

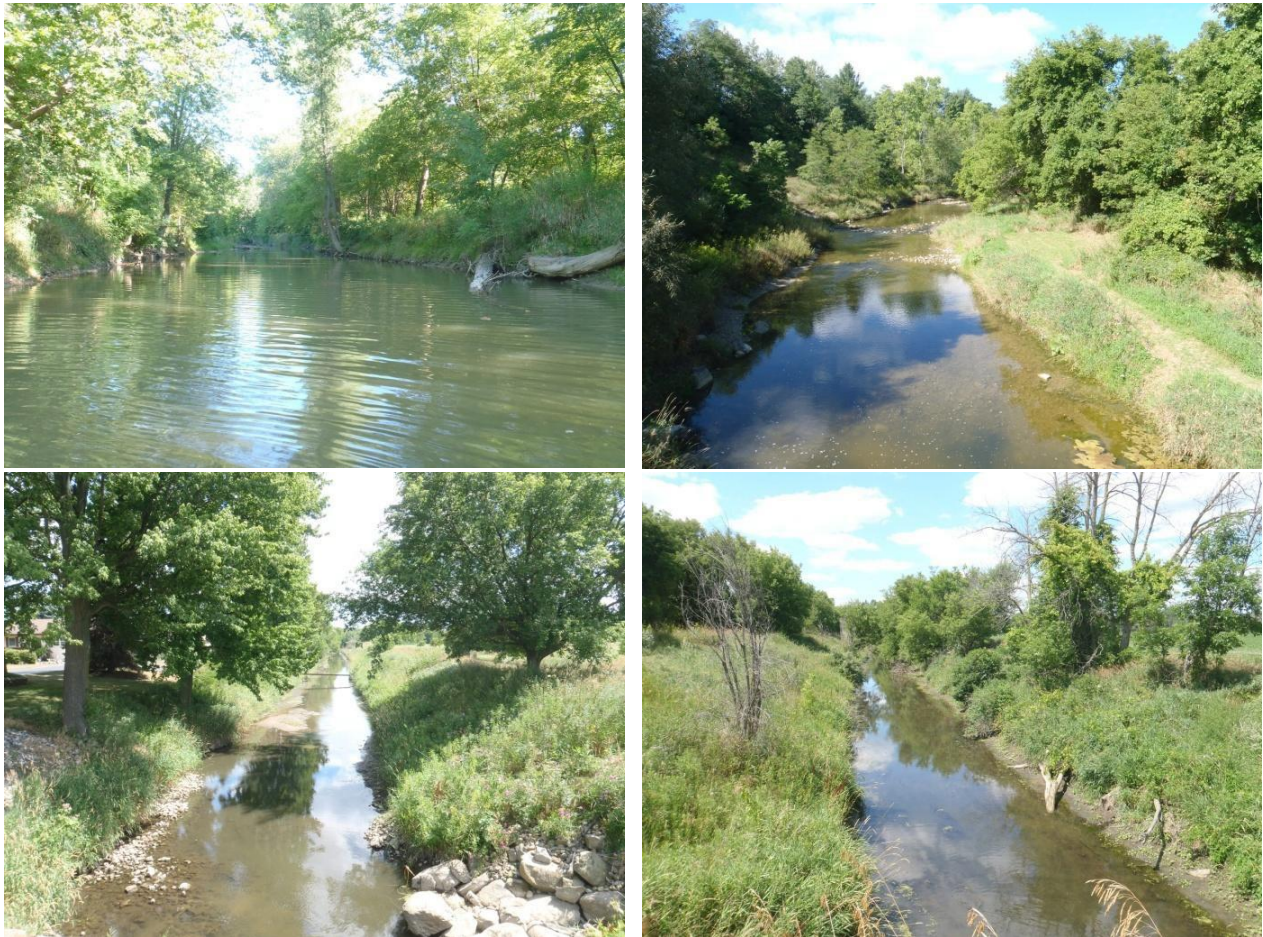
Figure 2.14 Representative photographs taken in the Belle River Watershed in July/August 2012: Top Left) Belle River at St. Clair Hwy (Station 28), Top Right) Belle River at Kronner Road (Station 29), Bottom Left) N. Br. Belle River at Newark Road d/s of Pinnacle (Vlastic) Foods outfall (Station 32), and Bottom Right) N. Br. Belle River at Newark Road u/s of Pinnacle (Vlastic) Foods outfall (Station 33) (MDEQ, 2013)

Additional macroinvertebrate sampling was completed in 2012 in the Belle River Watershed (Figure 2.14). Two sites in the North Branch Belle River rated as poor, indicative of not meeting the designated use for other indigenous aquatic life (Figure 2.15). In 2007, the North Branch Belle River sites had acceptable and poor benthic communities (Schmitt, 2008). Factors likely contributing to the poor scores

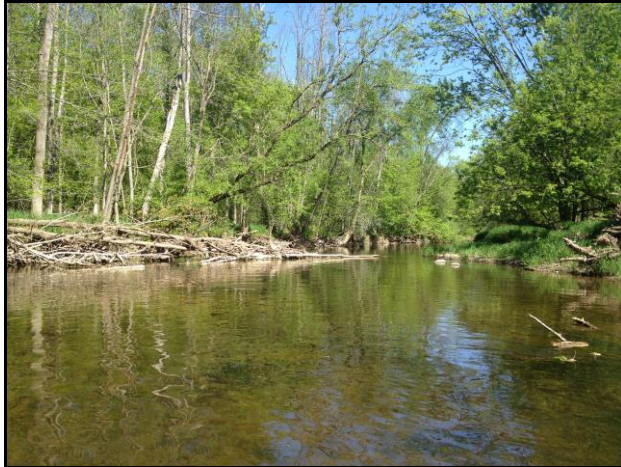
Figure 2.21 Reference Reach III on the Belle River upstream of Ashery Creek to Konner Rd.

- I. **Long Lake Drain:** south of Hunters Creek Rd. in Attica Township in Lapeer County
- II. **Pickrel Drain:** west of M-53 in Imlay Township in Lapeer County
- III. **Belle River:** upstream of Ashery Creek to Kronner Rd. in Richmond and Columbus Townships in St. Clair County (Figure 2.21)
- IV. **Jerome Creek:** 1,800 ft. west of Hessen Rd. in Richmond Township in St. Clair County
- V. **Unnamed tributary to the Belle River:** North of St. Clair Hwy; East of Allington Rd. in China Township in St. Clair County (Figure 2.22)
- VI. **Unnamed tributary to the Belle River:** South of Fred Moore Hwy; West of Allington Rd. in China Township in St. Clair County

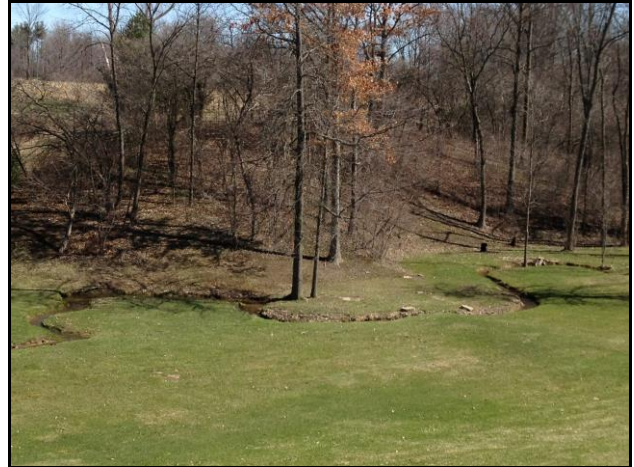
Figure 2.22 Reference Reach V on an unnamed tributary of the Belle River N. of St. Clair Hwy.

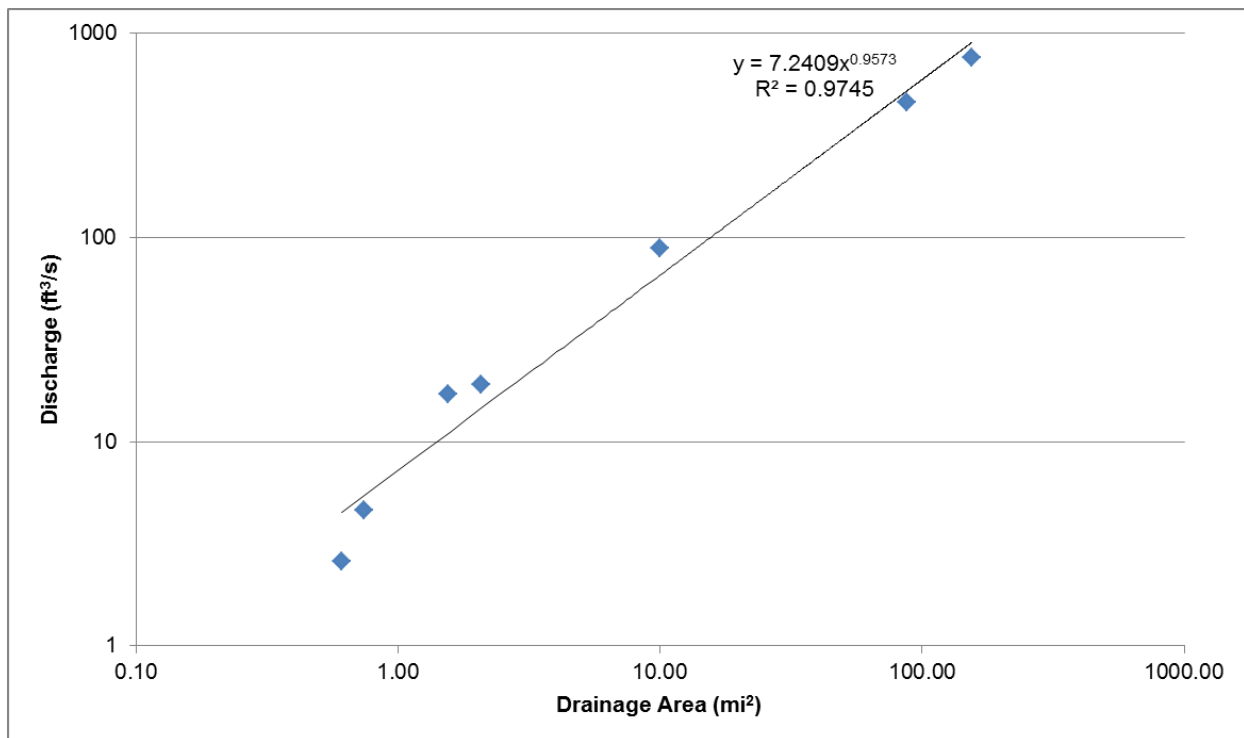
Figure 2.23 Localized regional curve of drainage area vs. bankfull discharge

The reference reach data was also used to develop localized regional reference curves for determining bankfull discharge, width, and cross-sectional area. These curves are important because they show relationships for stable, relatively un-impacted reaches in the Belle River Watershed. For example, the curve below could be used to quickly determine preliminary channel dimensions for two-stage ditches or river restoration, but should be verified based on local channel slope and roughness. Bankfull discharge can be approximated using the relationship in Figure 2.23.

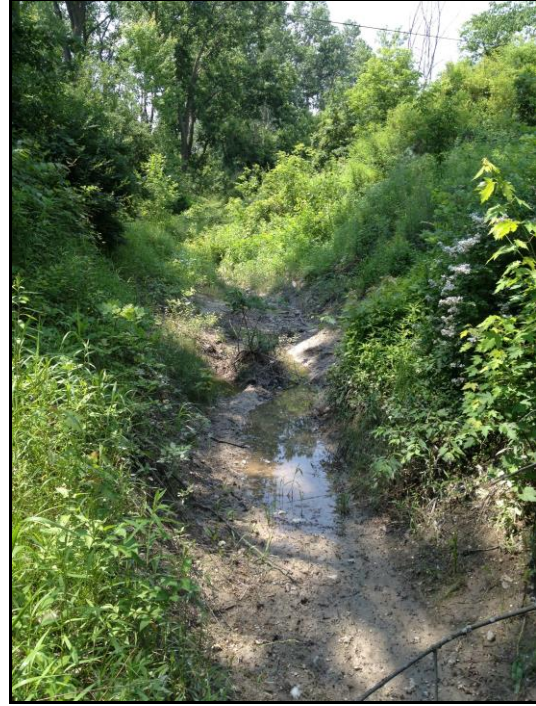
Degradation or incision is the erosion of the channel bottom that results in lowering its elevation (channel down-cutting). It was often difficult to determine where degradation was occurring due to changes in watershed conditions rather than due to dredging. A good measure of channel incision is the Bank Height Ratio (BHR) which is the existing bank height / bankfull maximum depth. The streambank erosion risk becomes moderate when the bank height is 1.2 times the bankfull depth or more. In the Belle River, there are five water courses that are actively down-cutting (Table 2.7). Many channelized drains have a high bank height ratio, but are not actively downcutting because they are too wide. Common causes of degradation include:

Figure 2.25 Example of channel downcutting in Schneider-China Drain (China Twp.)

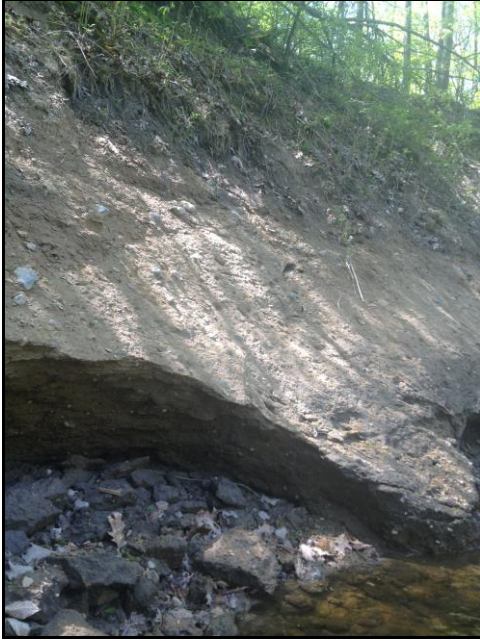
Figure 2.26 Hillslope failures on Belle River upstream of the Memphis gauge station

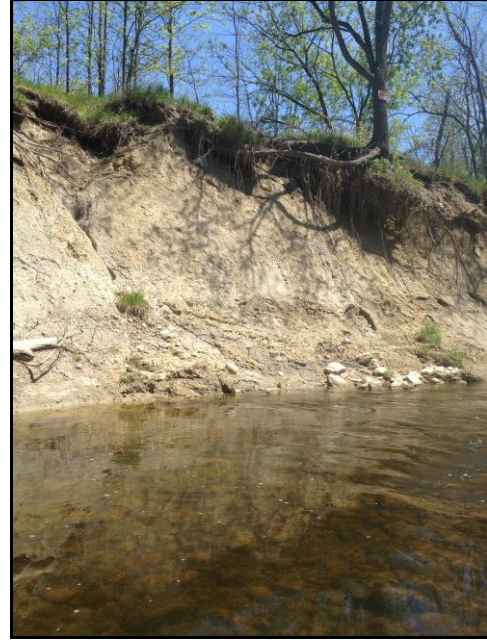
Figure 2.27 Hillslope failure on Belle River downstream of Memphis gauge station

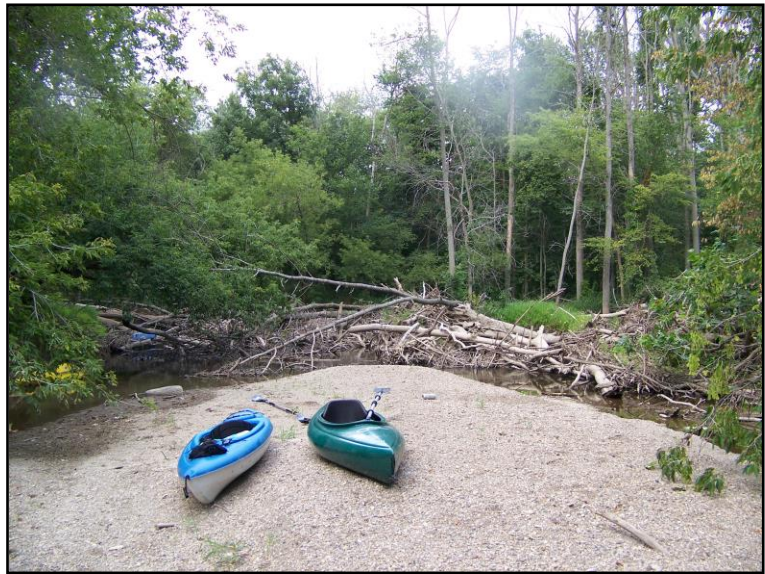
Manmade barriers, logjams, and cross-spanning logs were inventoried during the streambank erosion inventories. The inventory procedures and the complete inventory results and recommended priority management areas are provided in the “Belle River Management Plan for Large Woody Material” (Appendix I). Excessive logjams are a localized problem in the middle portion of the Belle River and some of its tributaries such as Jerome Creek and Ashery Creek (Figure 2.28). Logjams tend to be more extensive downstream of I-94 due to channel instability problems. Excessive wood is usually a symptom of wider-scale river instability problems. Some increase in wood loading is expected following ice storms, wind storms, or disease and pests such as Emerald ash borer. The amount of wood was excessive when channel enlargement, chute cutoffs, and river downcutting were present.

Figure 2.28 Extensive logjam on the Belle River, Columbus Township

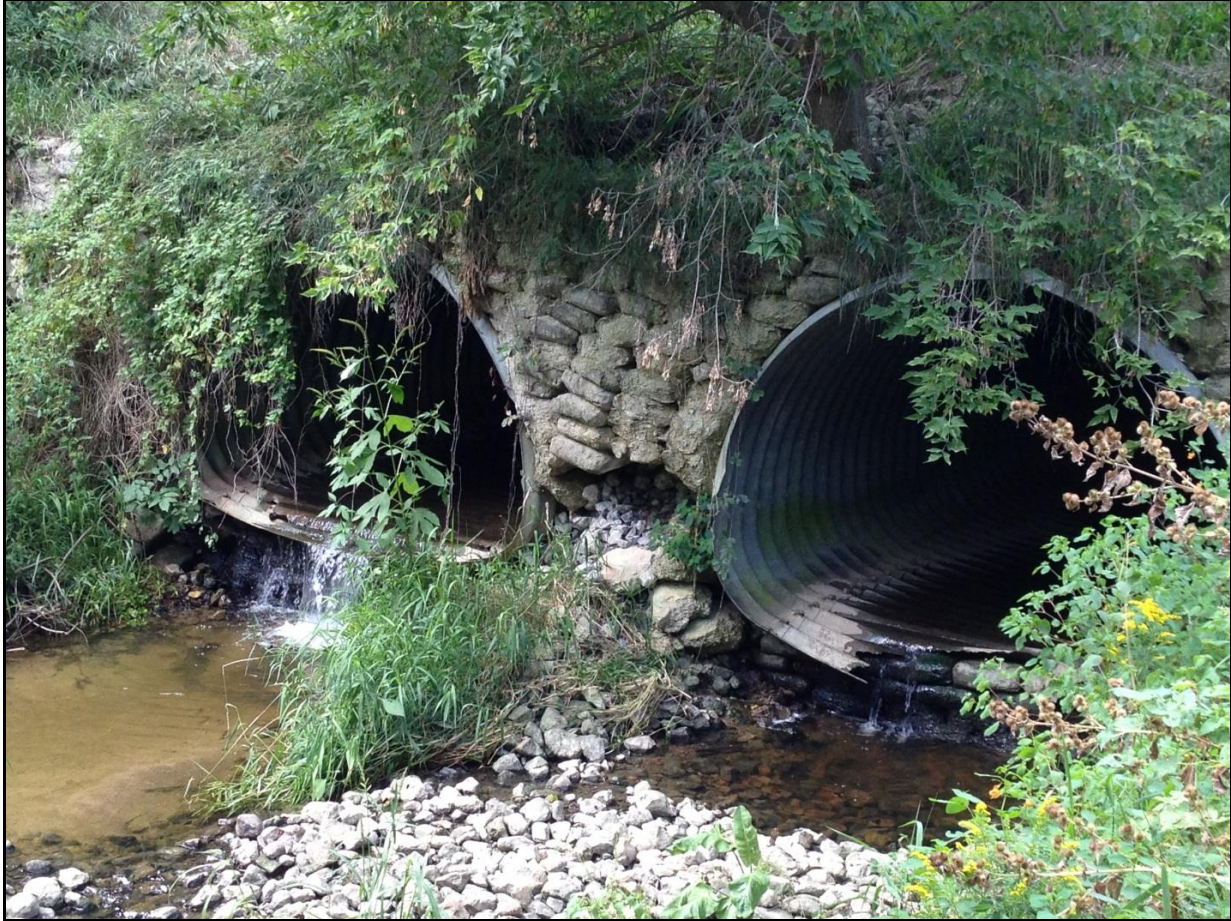
Road Stream Crossing: Jerome Creek at Church Road

The road crossing on Jerome Creek at Church Road in Casco Township is an example of a perched culvert that blocks fish migration (Figure 2.29). The under-sized culverts also cause channel deposition upstream and widening downstream. There is evidence of blockages and erosion due to road over-topping. Jerome Creek is deeply incised (downcutting) in this area. A single, wider bottomless arch culvert sized to the bankfull width (14-15 feet based on the localized regional curve) would be a better option. Grade controls are necessary downstream of the crossing to restore longitudinal connectivity. Two abandoned concrete cattle crossings upstream of Church Road are also contributing to localized channel instability problems.

Figure 2.29 Jerome Creek at Church Road crossing (facing upstream)

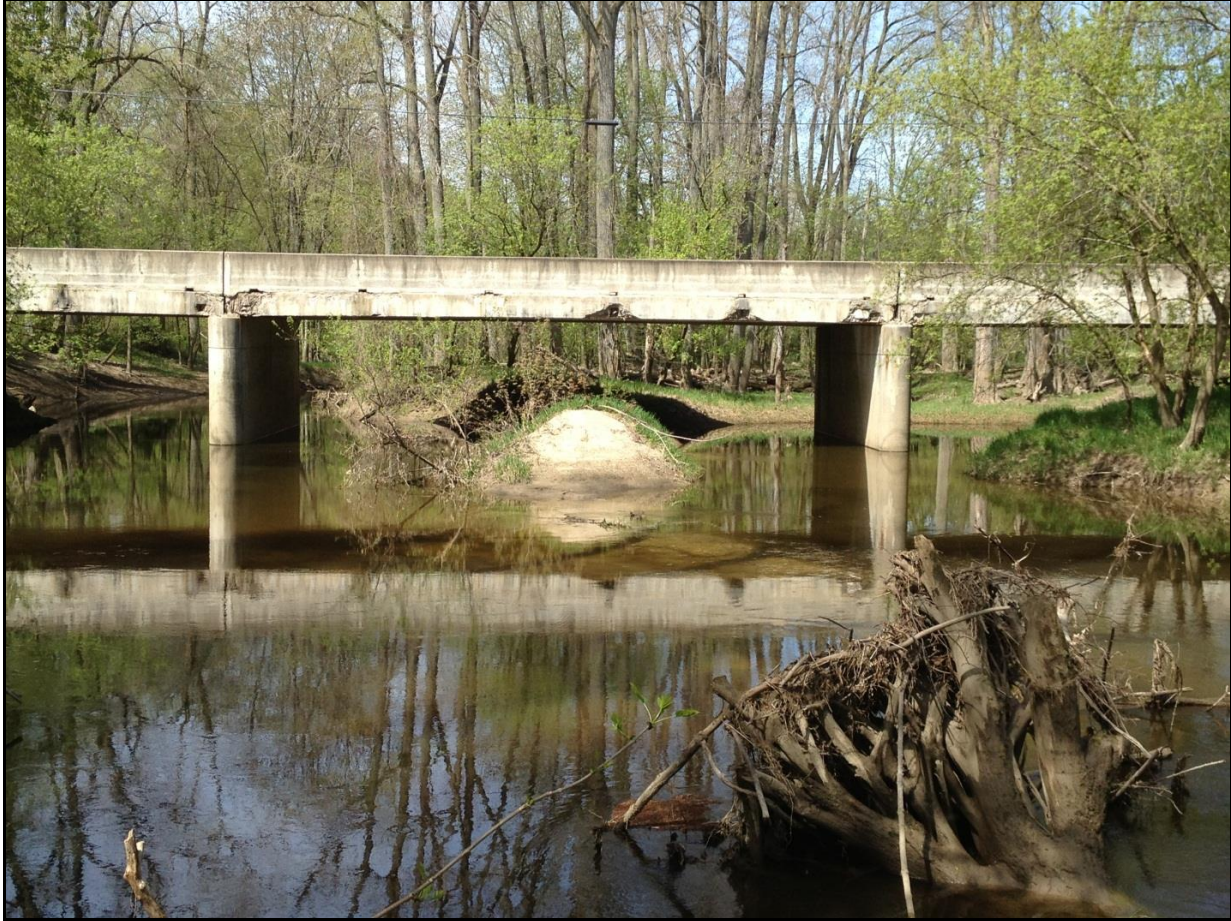
Road Stream Crossing: Belle River at Palms Road Bridge

The bridge crossing of the Belle River at Palms Road in Casco Township is an example of an over-wide channel crossing (Figure 2.30). The bridge opening was constructed much larger than the channel and the river was likely dragged under the road to increase flood capacity. This provides short-term flood stage reduction but causes channel instability due to several factors: 1) the increased channel width causes excessive deposition and mid-channel bars, 2) dredging increases bank heights which can cause erosion and increased logjams due to the inability to pass debris, 3) river straightening can increase scour and vertical instability. The flow should be directed through the central cell of the bridge with a low bench constructed within each of the side cells up to the bankfull elevation to improve channel stability, reduce flooding, and maintenance. River crossings should typically be constructed as riffles to improve sediment and wood transport to reduce maintenance and loss of flood capacity.

Figure 2.30 Belle River at Palms Road crossing (facing upstream)
