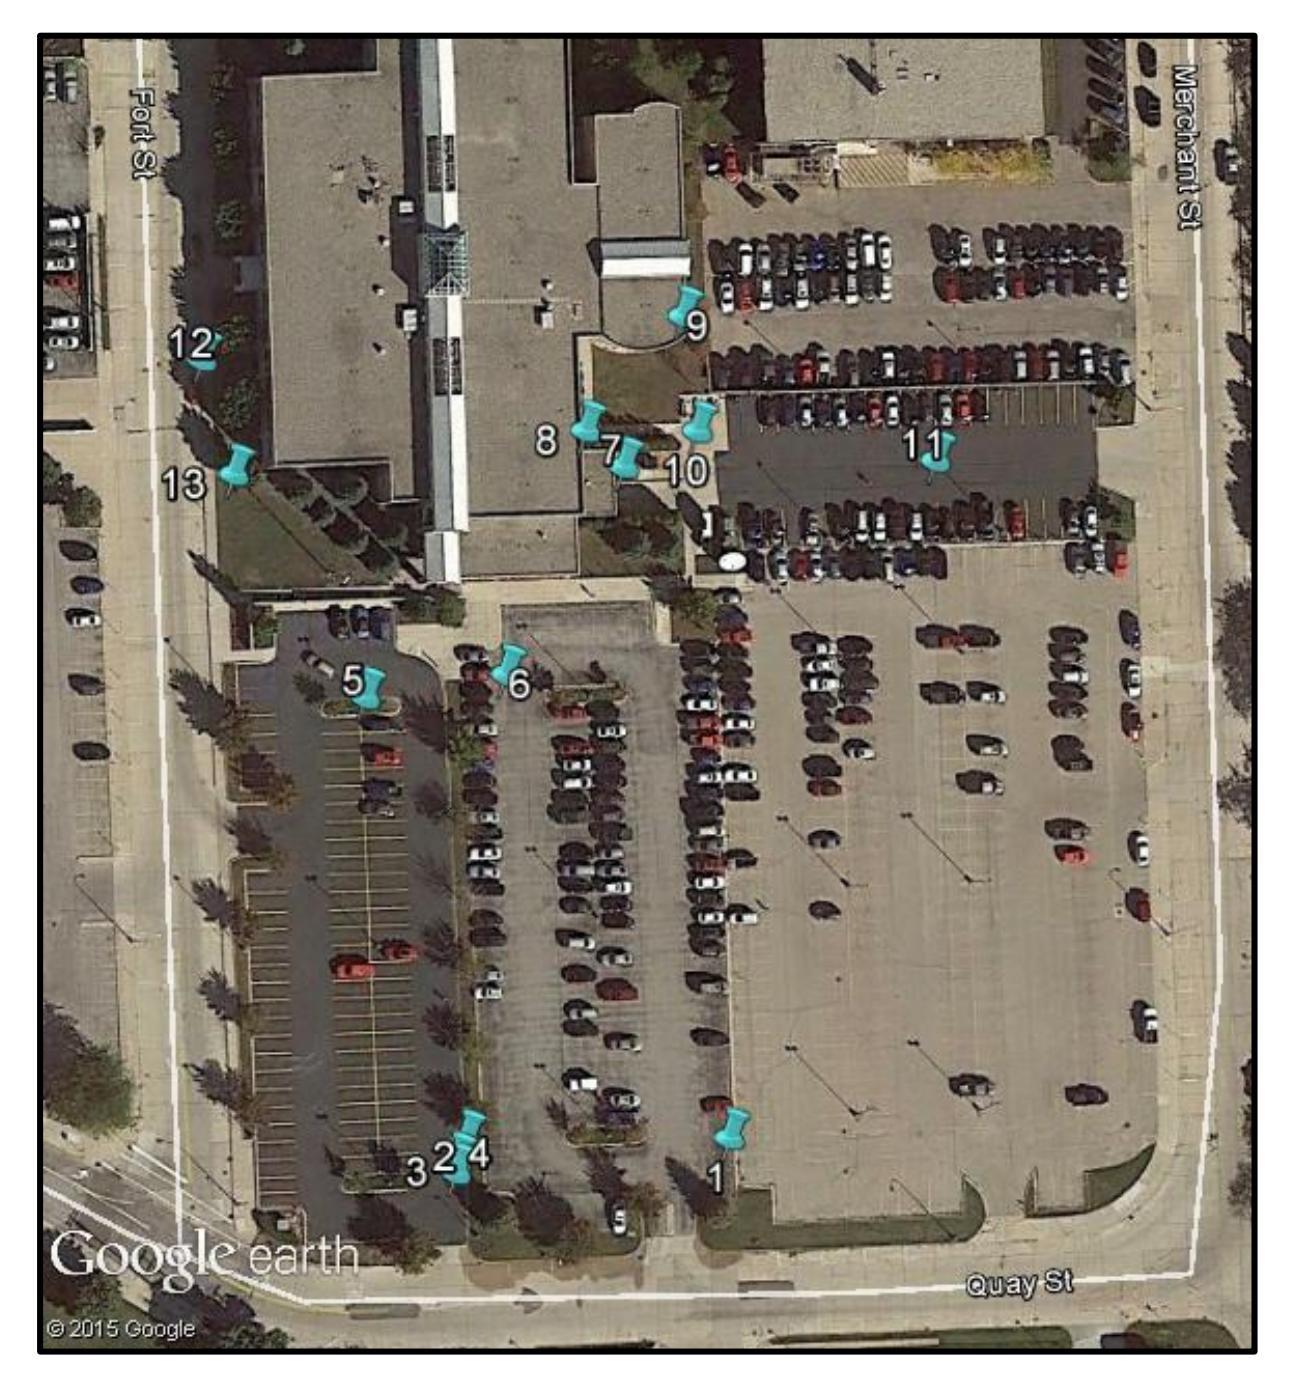
Figure 1.Reference Map

7	42.97648	-82.421223	Sediment: 1" to 2" sediment—monitor and re-check in 2017	Low
			Water: Standing water present	
8	42.97653	-82.421294	Water: Dry	Low
			Other: Cigarette butts at bottom of structure—signage	
			recommended for not dispersing cigarette butts in catch basin	
9	42.97669	-82.42111	Sediment: No sediment	Low
			Water: Dry	
10	10.07(50	02 421002	Structure: Good condition	
10	42.97653	-82.421083	Sediment: No sediment	Low
			Structure: Good condition	
11	42.97649	-82.42063	Sediment: Approximately 8" sediment—removal of sediment	Medium
			recommended	
			Water: Standing water present	
12	42.97663	-82.42203	Sediment: No sediment	Low
			Water: Standing water present	
			Other: No vegetation around structure	
13	42 97647	-82 42197	Water: Flow present	Low
15	42.77047	-02.42197	Structure: Good condition	LOW
			Other: No vegetation around structure

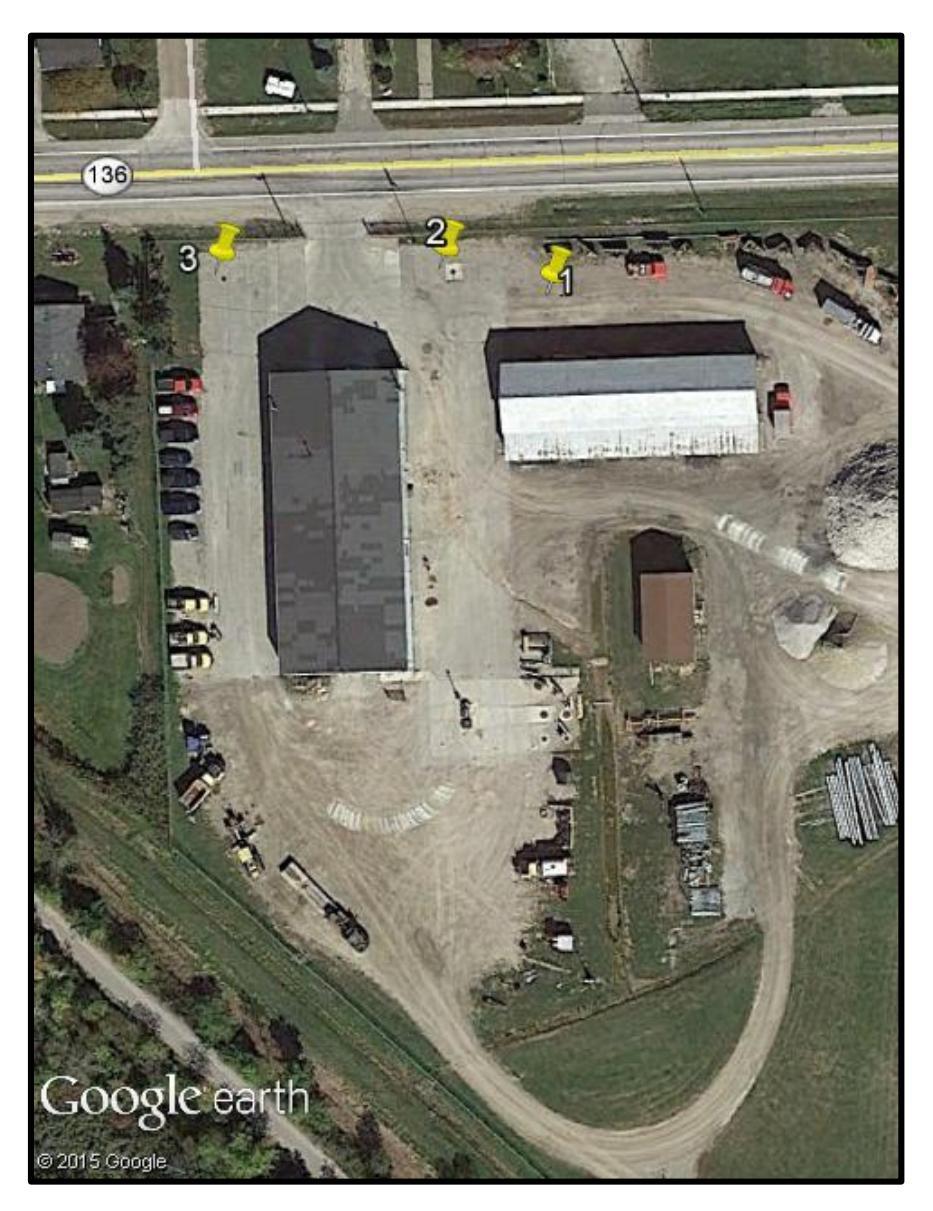
Figure 1.Reference Map

Number on Map	Latitude	Longitude	Inspection Notes/Maintenance Required	Priority
1	43.06184	-82.6878	Sediment: 2" to 3" sediment—monitor and re-check in 2017 Water: Minor turbidity (cloudiness) Structure: Minor corrosion of interior pipemonitor	Medium
2	43.06188	-82.688	Sediment: Approximately 1" sediment—monitor and re-check in 2017	Low
3	43.06188	-82.6884	Sediment: 4" to 5" sediment—monitor and re-check in 2017	Low

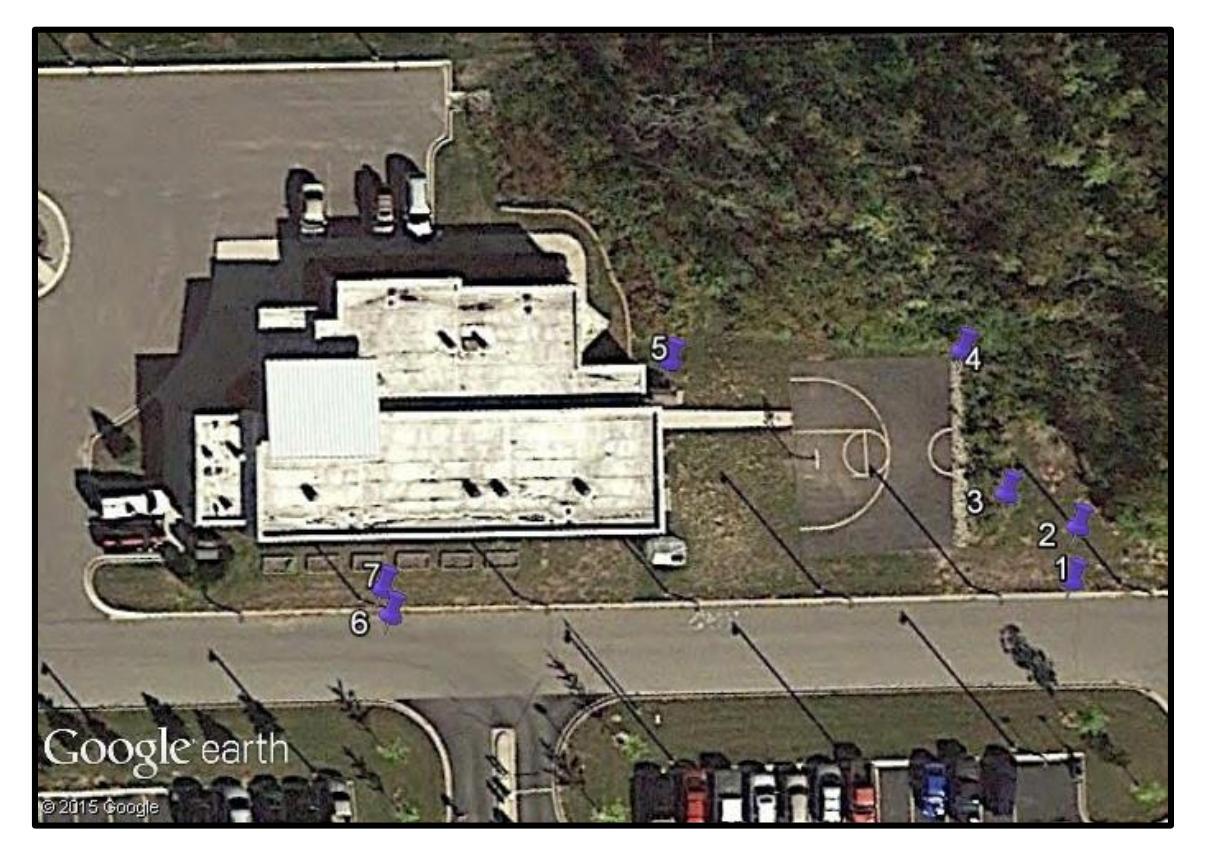
Figure 1.Reference Map

Number	Latitude	Longitude	Inspection Notes/Maintenance Required	Priority
on Map				
1	42.9434417	-82.479887	Sediment: Approximately 26" sediment – removal of sediment recommended	High
2	42.943481	-82.479881	Sediment: Approximately 26" sediment – removal of sediment recommended	High
3	42.943505	-82.479952	Sediment: South catch basin within bioswale: approximately 18" sediment – removal of sediment recommended Structure: Bioswale	High
4	42.943601	-82.480283	Structure: North catch basin within bioswale: good condition	Low
5	42.9436083	-82.479995	Structure: Bioswale, good condition Other: Noted phragmites in swale	Low
6	42.943419	-82.480557	Sediment: Approximately 4" sediment – monitor and re-check in 2017	Low
7	42.943438	-82.480565	Other: Covered with leaves/debris – remove debris	Medium

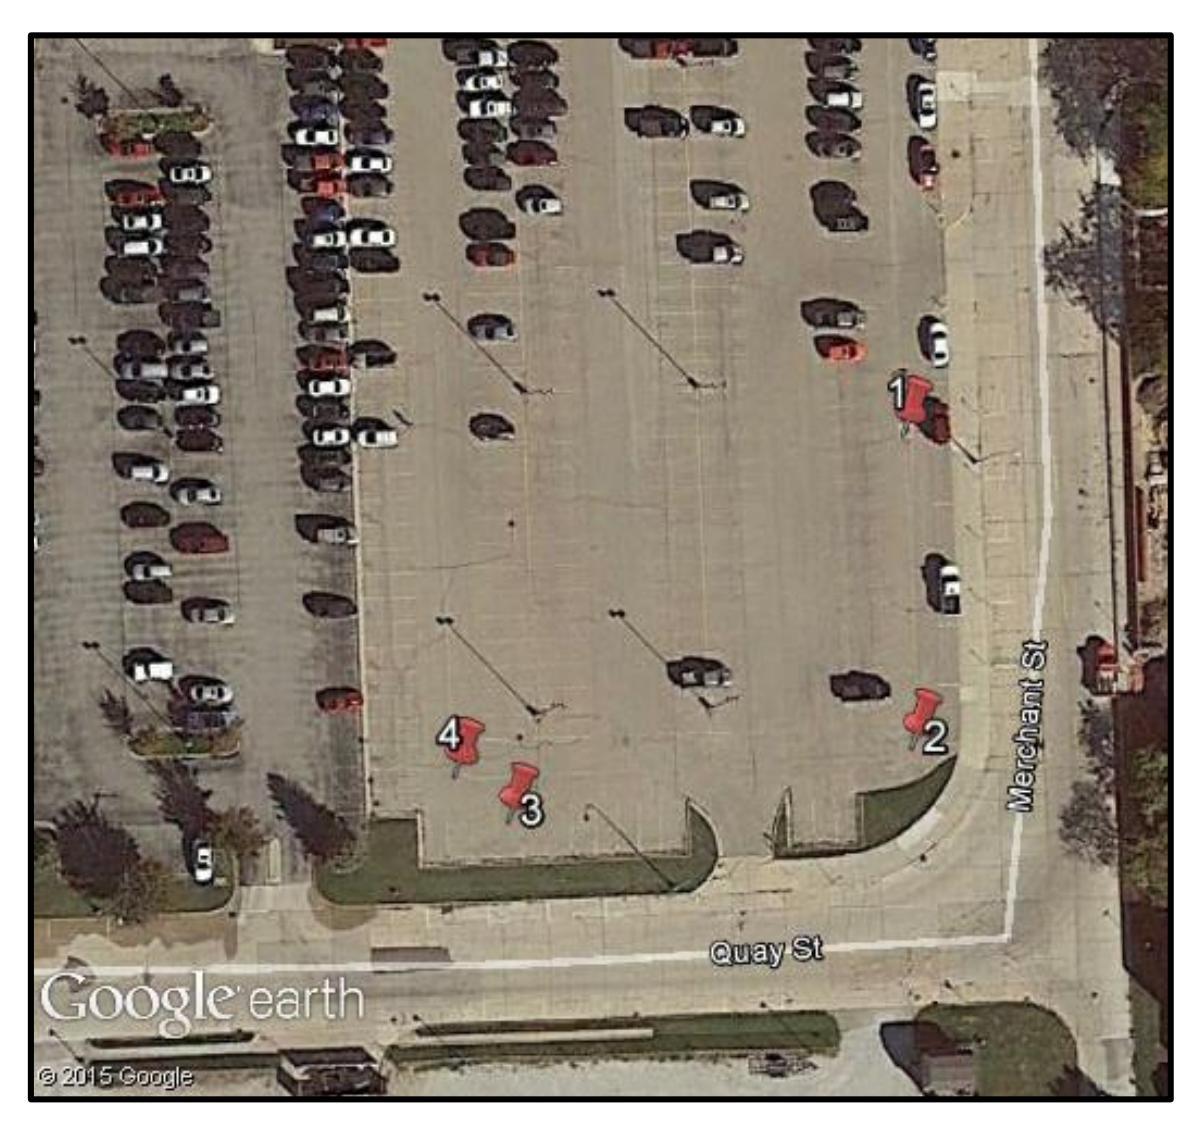
Figure 1.Reference Map

Number on Map	Latitude	Longitude	Inspection Notes/ Maintenance Required	Priority
1	42.975875	-82.420273	Sediment: Approximately 3" sediment (gravel) – monitor and re-check in 2017	Low
2	42.975561	-82.420261	Sediment: Approximately 3" sediment –monitor and re-check in 2017	Low
3	42.975488	-82.420813	Water: Dry Structure: Good condition	Low
4	42.9755333	-82.420887	Water: Dry Structure: Good condition	Low

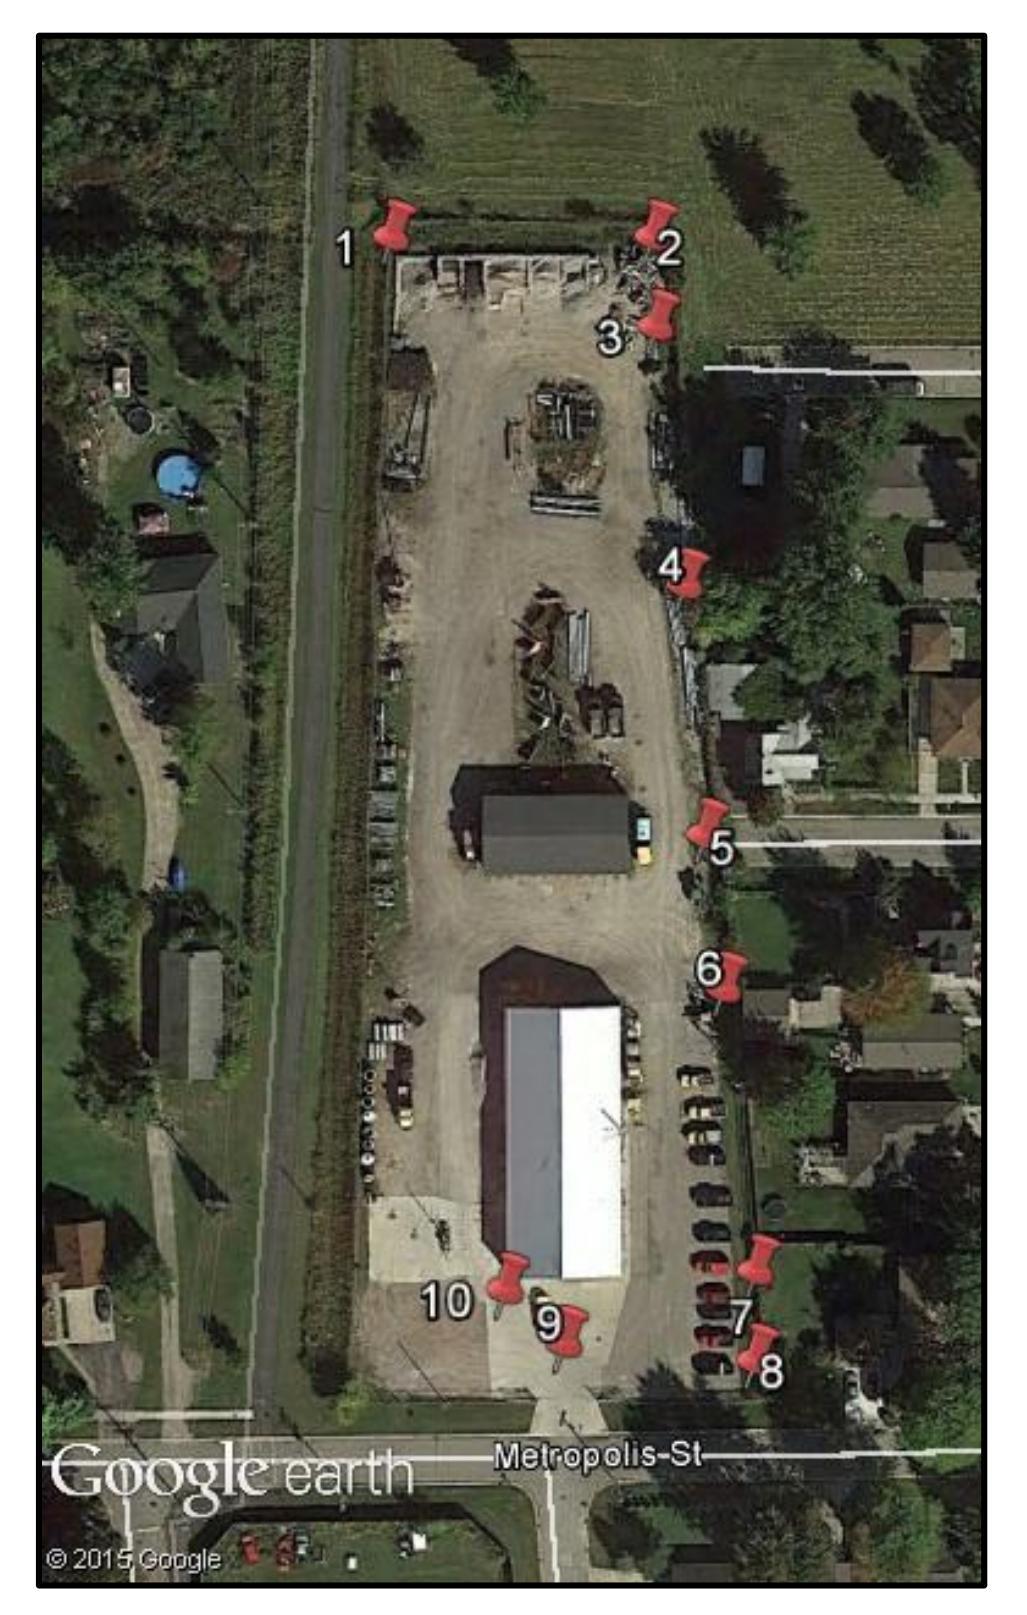
Figure 1.Reference Map

Number on Map	Latitude	Longitude	Inspection Notes/Maintenance Required	Priority
1	42.724022	-82.501365	Water: Standing water present Structure: Good condition	Low
2	42.724021	-82.500841	Water: Standing water present Structure: Good condition	Low
3	42.7238889	-82.500833	Water: Standing water present Structure: Good condition	Low
4	42.72351	-82.500773	Sediment: Silt sack present – clean out/remove sediment annually	Medium
5	42.723144	-82.500732	Structure: T-structure, good condition	Low
6	42.72292	-82.500694	Sediment: Too deep to measure, removal of sediment recommended Structure: T-structure. Over-sized and crooked lid – repair Other: Noted sink hole near side	High
7	42.7225083	-82.500628	Sediment: 13" sediment – removal of sediment recommended	High
8	42.722378	-82.50063	Sediment: 18" sediment – removal of sediment recommended	High
9	42.722404	-82.501009	Sediment: 21" sediment – removal of sediment recommended	High

10	42.722482	-82.501126	Sediment: 14" sediment – removal of sediment recommended	High

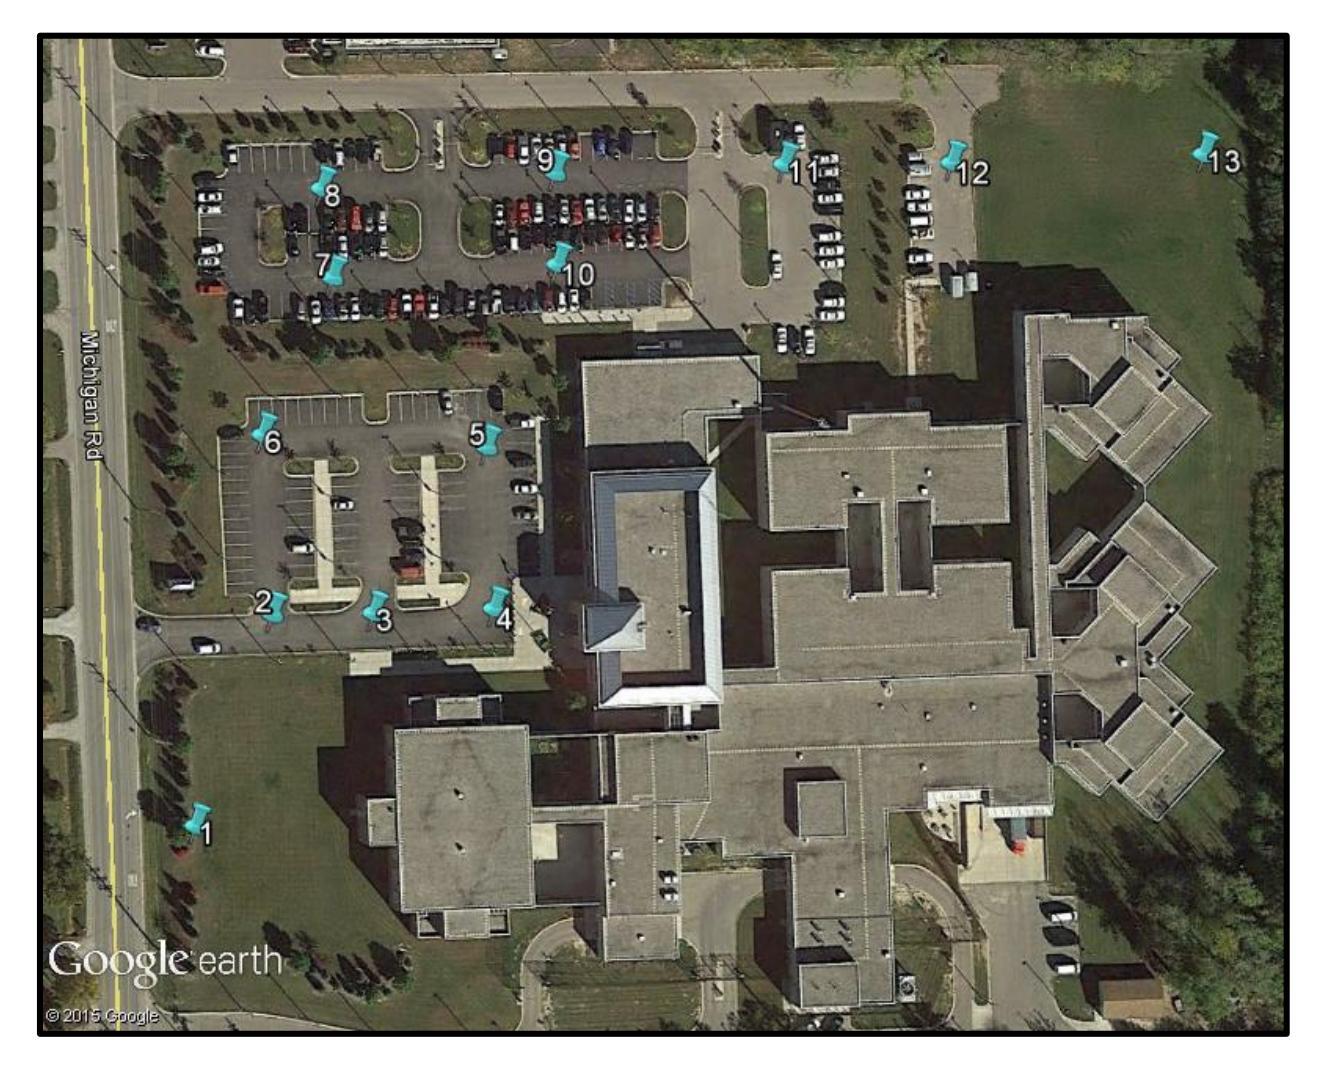
Figure 1.Reference Map

11	42.9432567	-82.479542	Sediment: Approximately 2" sediment –Monitor and re-check in 2017 Structure: Good condition	Low
12	42.94326	-82.479104	Sediment: Approximately 3" sediment –monitor and re-check in 2017	Low
13	42.9432767	-82.478445	Structure: Good condition	Low

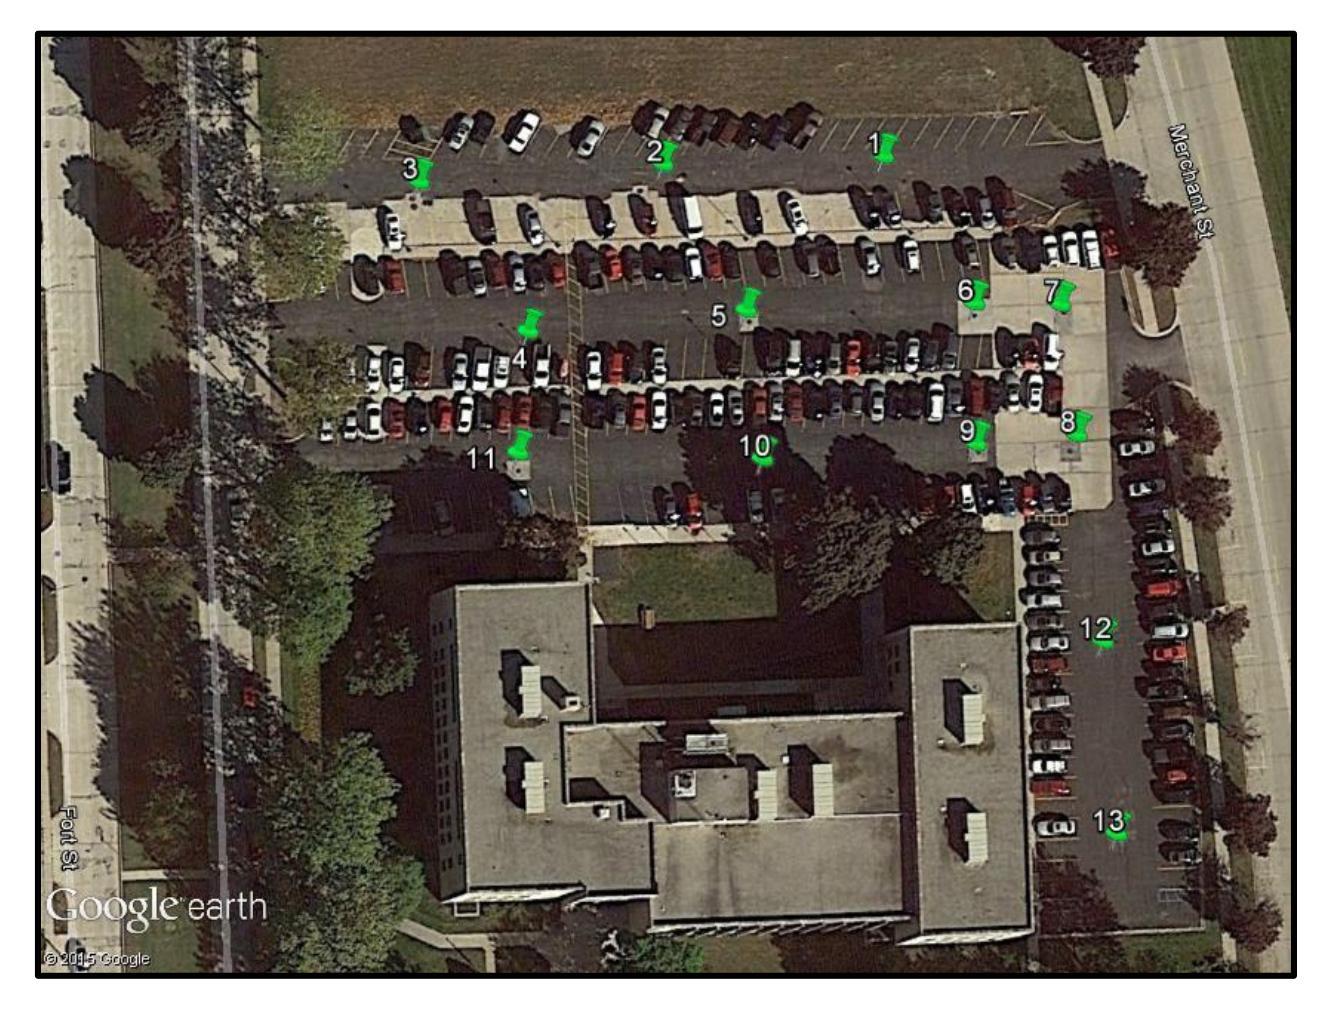
Figure 1.Reference Map

9	42.97963	-82.4208	Sediment: approximately 1" sediment—monitor and re-check in 2017 Water: Standing water present	Low
10	42.97963	-82.4212	Sediment: Too deep to measure, approximately 1" to 2" sediment—monitor and re-check in 2017.Water: Standing water present	Low
11	42.97963	-82.4216	Sediment: Approximately 1" sediment—monitor and re-check in 2017 Water: Standing water present	Low
12	42.97944	-82.4206	Sediment: 1" to 2" sediment—monitor and re-check in 2017 Water: Standing water present	Low
13	42.97918	-82.4207	Sediment: 1" to 2" sediment—monitor and re-check in 2017 Water: Standing water present	Low

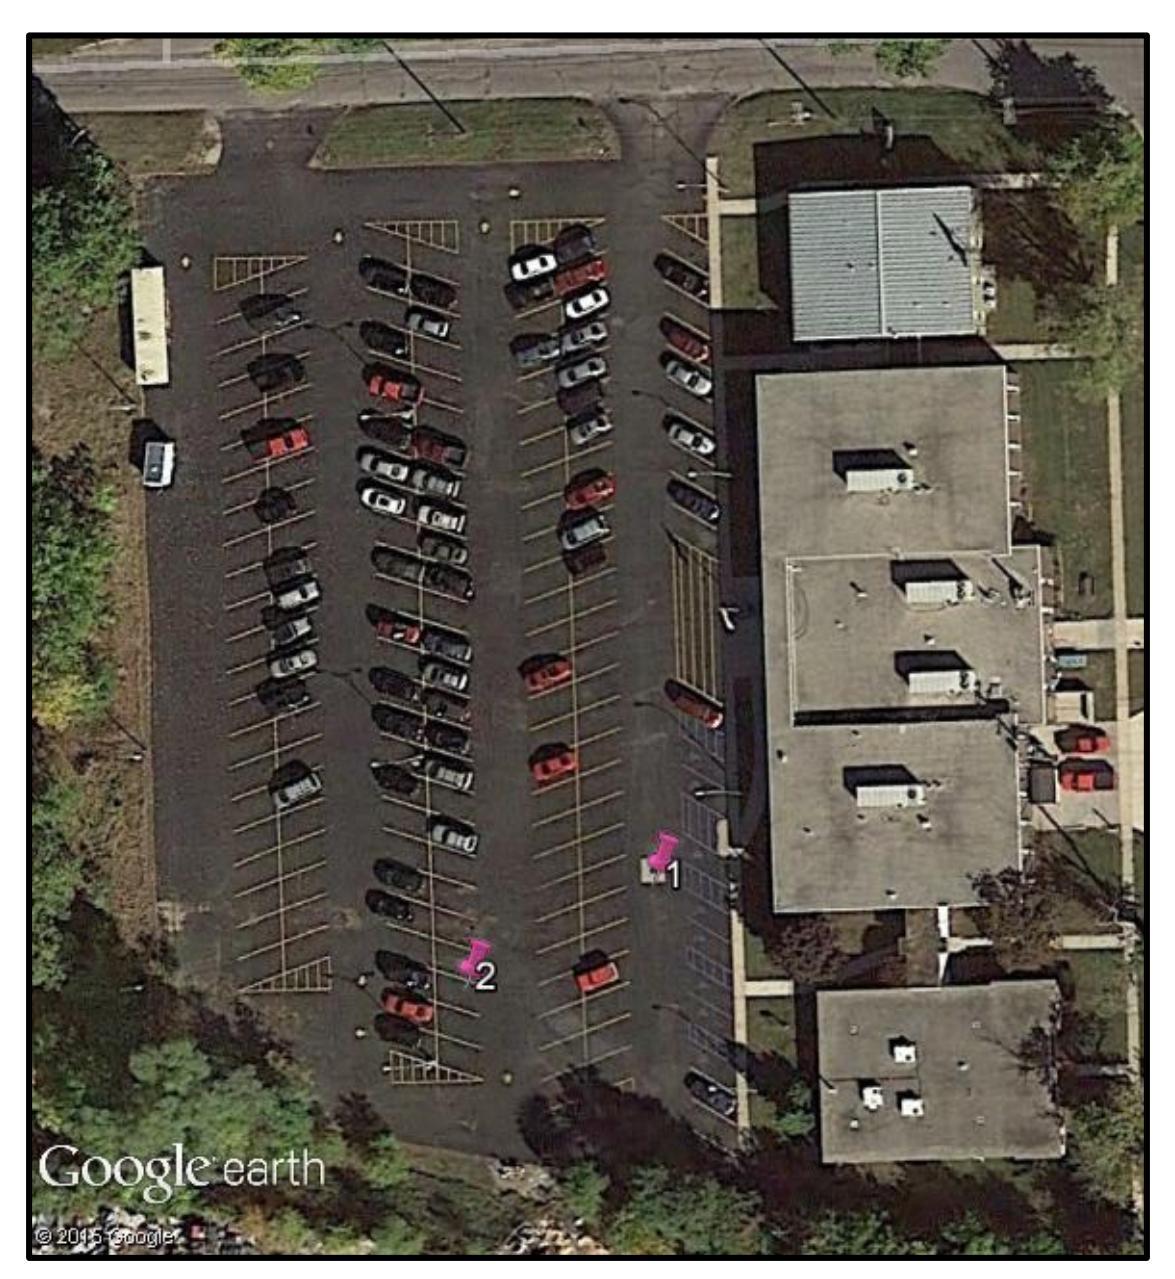
Figure 1: Reference Map

Number on Map	Latitude	Longitude	Inspection Notes/Maintenance Required	Priority
1	42.943543	-82.457073	Sediment: Approximately 3" sediment – monitor and re-check in 2017	Low
2	42.9434433	-82.457317	Structure: Good condition	Low

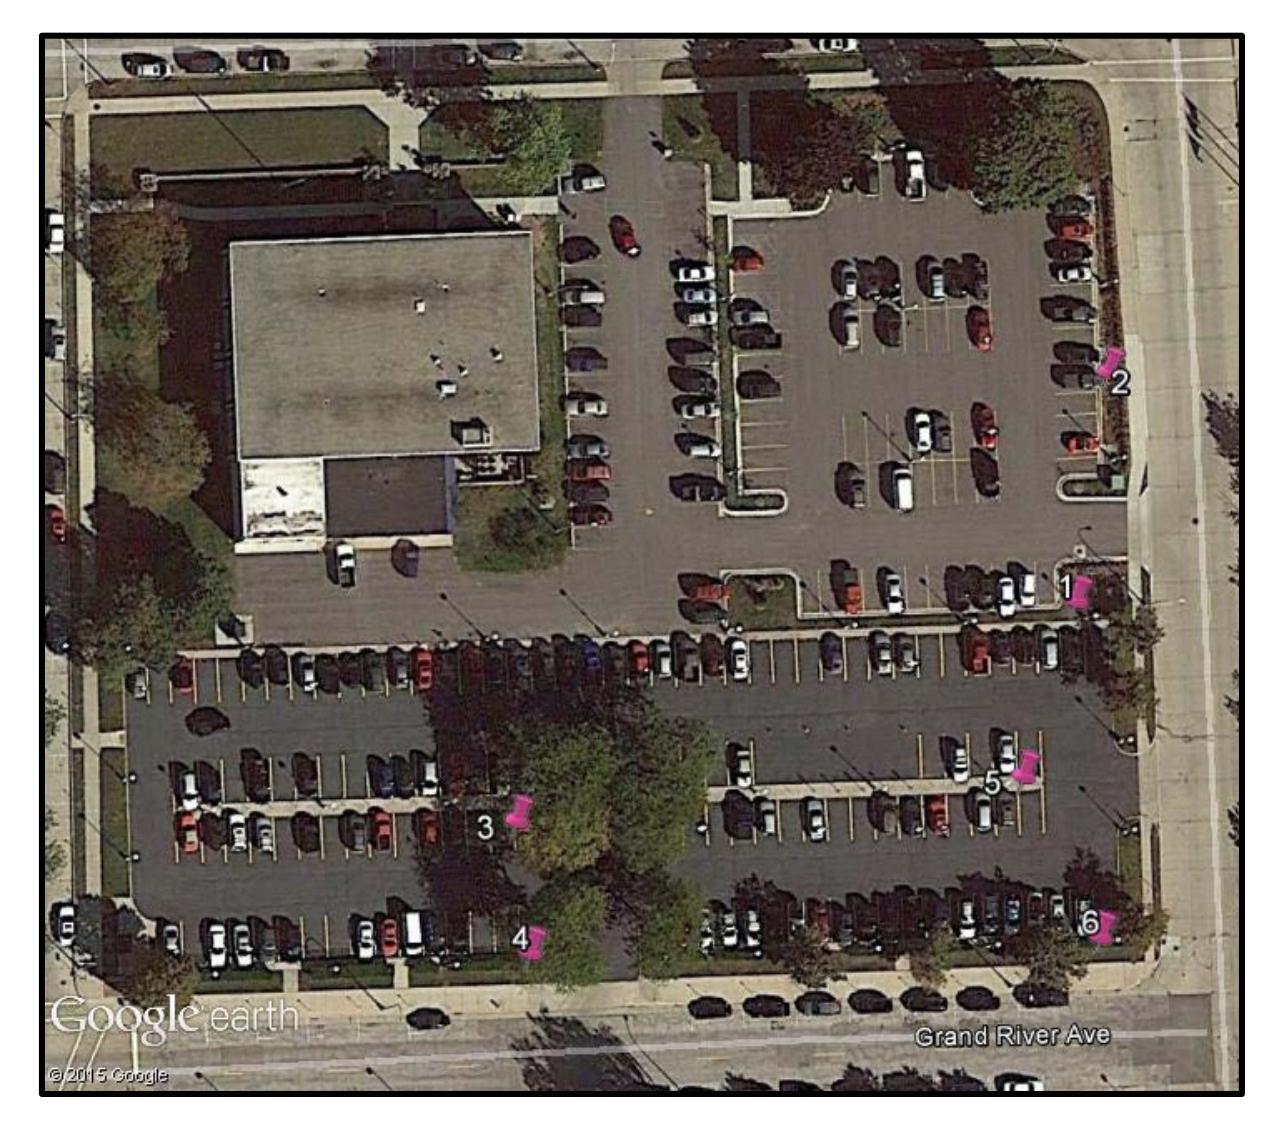
Figure 1.Reference Map

Number on Map	Latitude	Longitude	Inspection Notes/Maintenance Required	Priority
1	42.97802	-82.4204	Sediment: No sediment	Low
			Structure: Good condition	
2	42.97828	-82.4204	Sediment: Approximately 1" sediment-monitor and re-check in	Medium
			2017	
			Structure: Minor concrete crackingmonitor	
3	42.97777	-82.4213	Sediment: 1" to 2" sediment—monitor and re-check in 2017	Low
4	42.97762	-82.4213	Sediment: 1" to 2" sediment—monitor and re-check in 2017	Low
5	42.97782	-82.4205	Sediment: Approximately 1" sediment-monitor and re-check in	Low
			2017	
			Water: Dry	
			Other: Small amounts of debris around exterior and interior of	
			structure—remove debris	
6	42.97764	-82.4204	Sediment: 1" to 2" sediment—monitor and re-check in 2017	Low
			Water: Standing water present

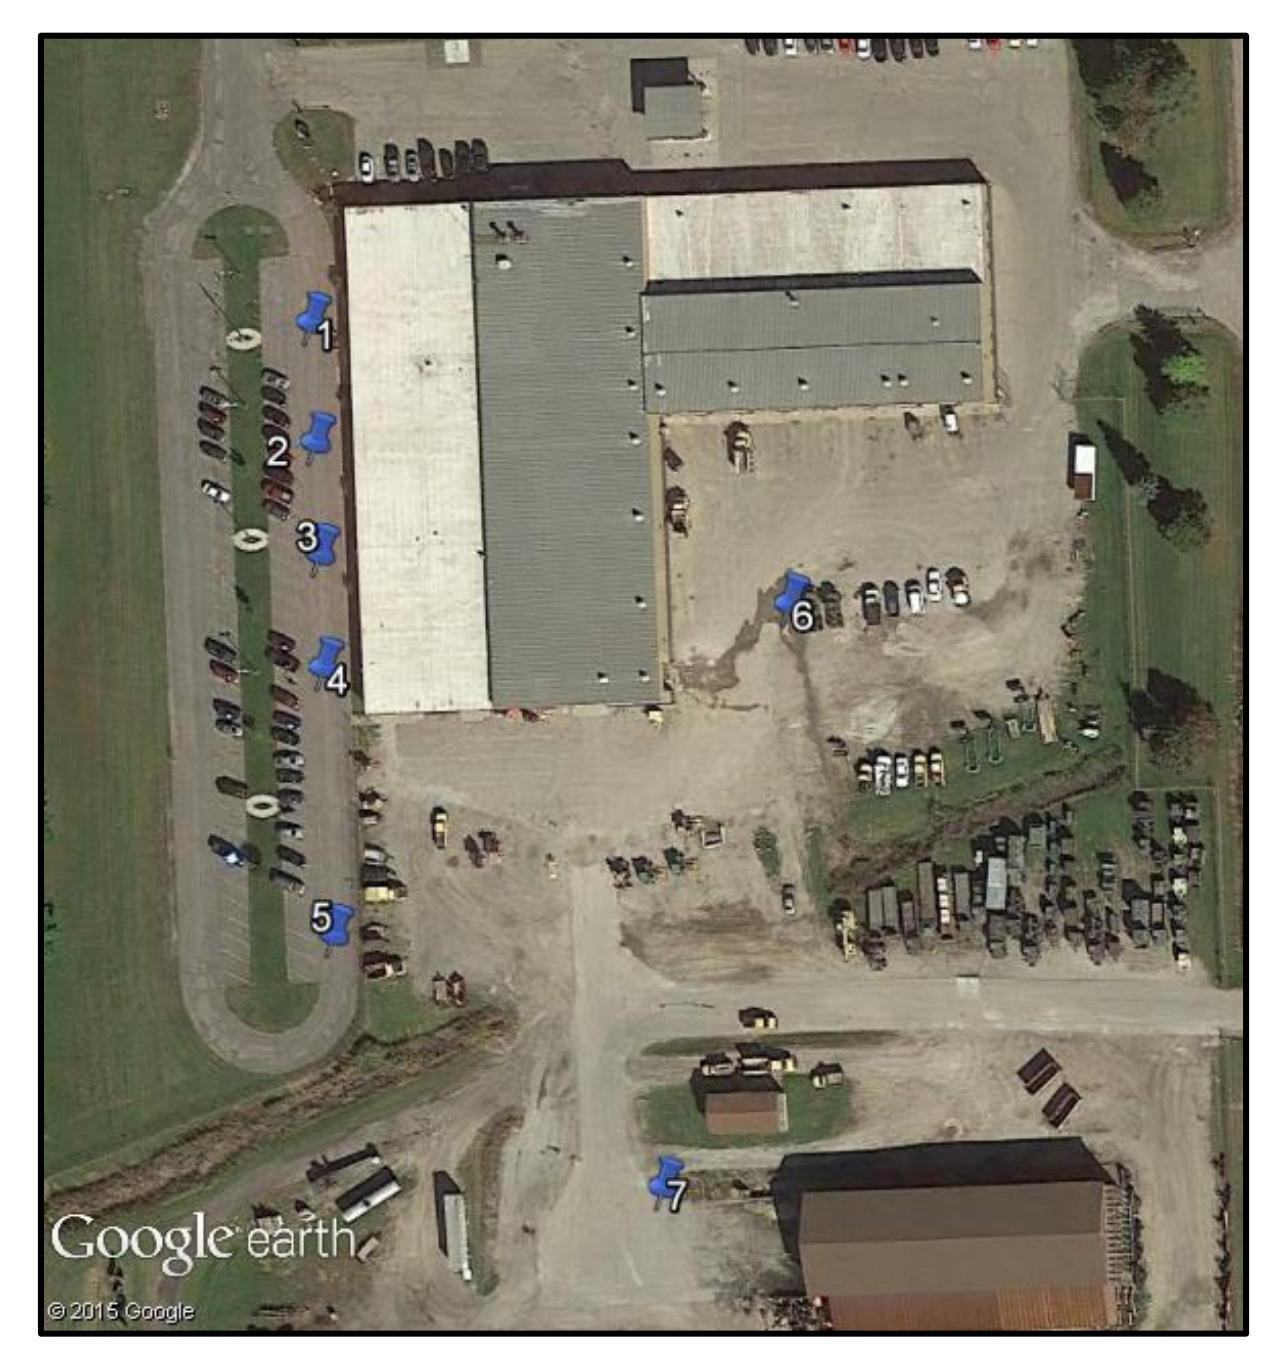
Figure 1.Reference Map

Number on Map	Latitude	Longitude	Inspection Notes/Maintenance Required	Priority
1	42.904267	-82.52133	Structure: Good condition	Low
2	42.90407	-82.521321	Sediment: Approximately 7" sediment – removal of sediment recommended Structure: Chipped/missing blocks – repair	High
3	42.903887	-82.521311	Sediment: Approximately 1" sediment Structure: Good condition	Low
4	42.9037	-82.521303	Sediment: 2" sediment – removal of sediment recommended Structure: Chipped/missing blocks - repair	High
5	42.903261	-82.521282	Structure: Chipped/missing blocks - repair	
6	42.903805	-82.520257	Sediment: 13" sediment – removal of sediment recommended	High
7	42.902845	-82.520542	Sediment: 14" sediment – removal of sediment recommended	High
