# Columbus Bible Church Dismantling

## Chronology

## The Old Way of Construction: Post and Beam

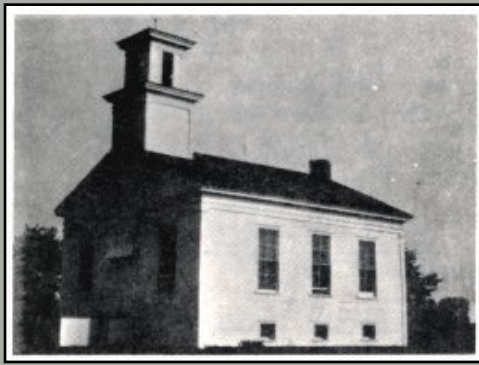
**2** Church after the floor was raised in 1930.

**1930-** The floor was raised to make room for a furnace.

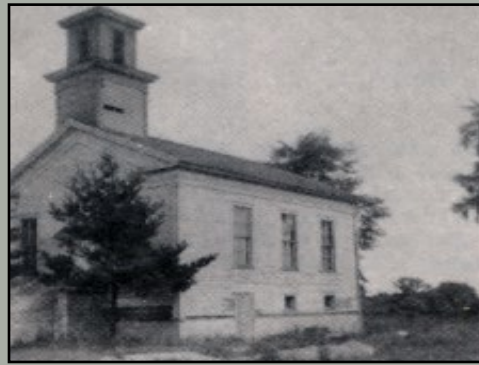
**3** Raised again for a new foundation in 1951.

**1951-** The church was raised and a new foundation added to make room for a social hall. It was at this time the original belfry was removed.

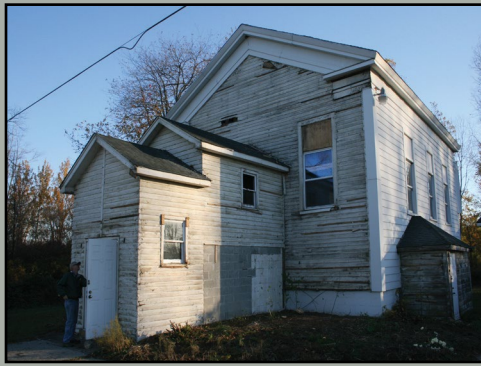
**5** Deconstruction begins 10/18/2010.

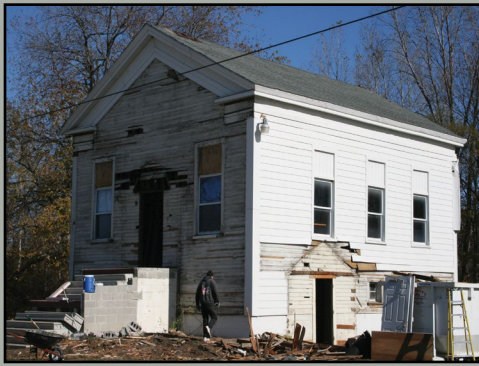
**6** Covered porches removed 10/19/2010.

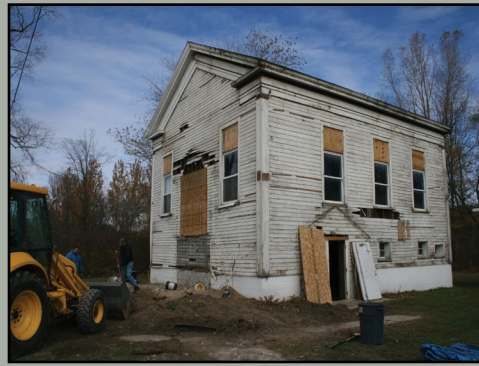
**7** Block steps removed 10/23/2010.

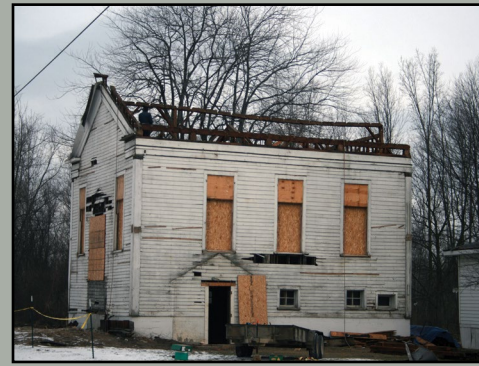
**8** Contractor begins dismantling 1/10/2011.

The Amish, who are well versed in barn raising, are very familiar with post and beam, mortise and tenon construction. An Amish contractor from Brown City was hired to dismantle and reassemble the church.

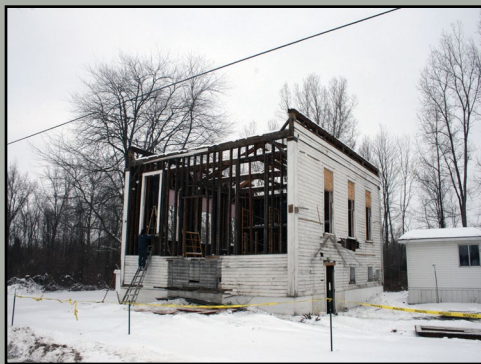
**9** Roof trusses and front siding removed 1/14/2011.

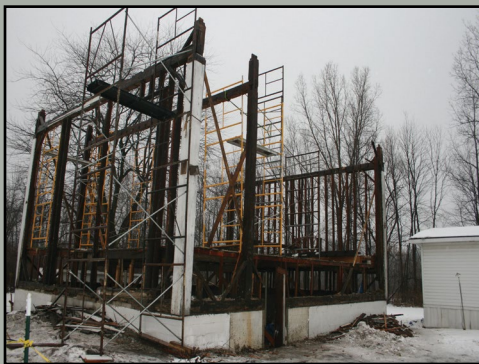
**10** Side walls and cross beams removed 1/18/2011.

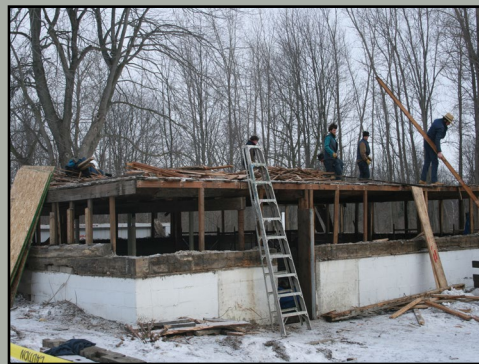
**11** Upper walls removed 1/20/2011.

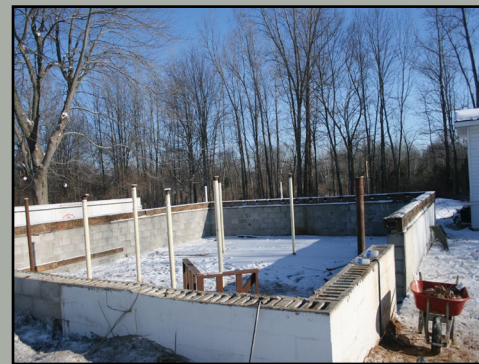
**12** Dismantling completed 1/21/2011.

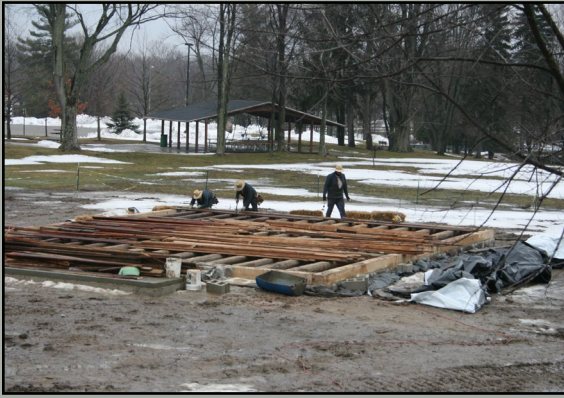
Original floor joists being reinstalled on a new foundation

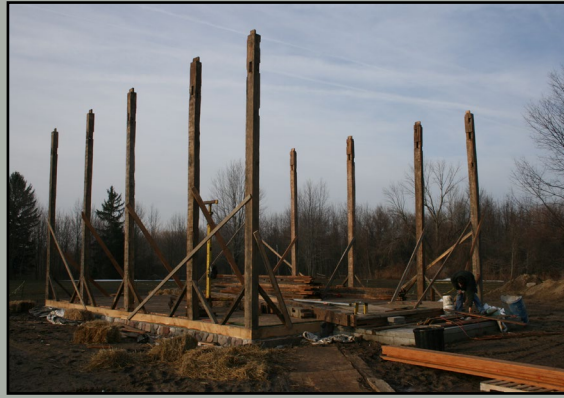
Wall posts are set. These are all the original posts.

In 1860, when the Columbus Bible Church was built, buildings were constructed using a technique known as post and beam. This meant that the frame work was made from large timbers that were often hand hewed (shaped square by hand, instead of using a sawmill). The timbers were joined together by interlocking joints called mortis and tenons. Those joints were then secured by large wooden pegs.

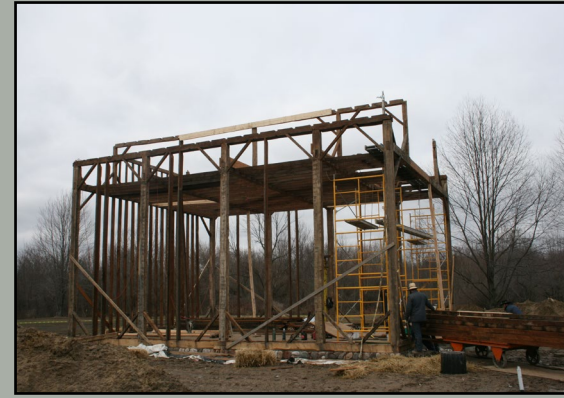
Summer beams and girts are reinstalled. These are the horizontal posts that connect to the wall posts

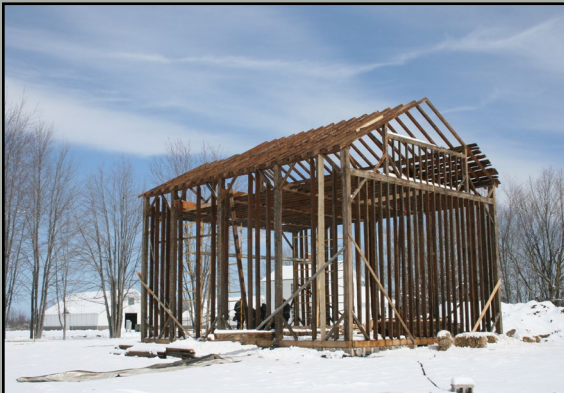
Wall studs and rafters are installed. Over 90% of this material is original.

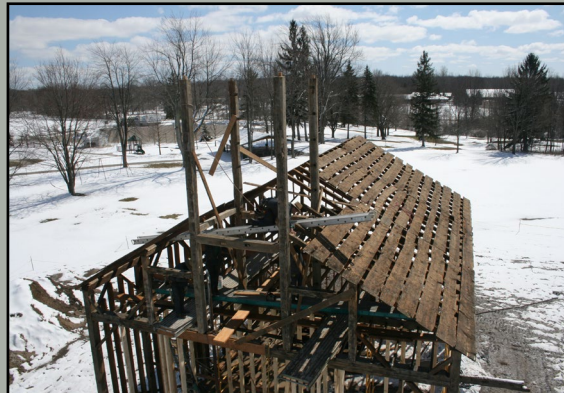
The original belfry was removed in the 1950s. By using original markings and photos, the belfry was re-created.

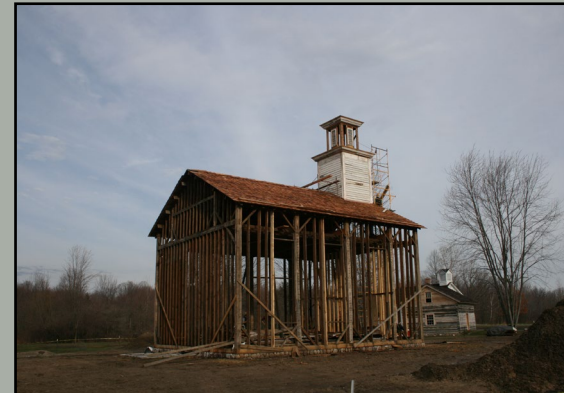
Belfry taking shape and the Cedar shingles are installed.

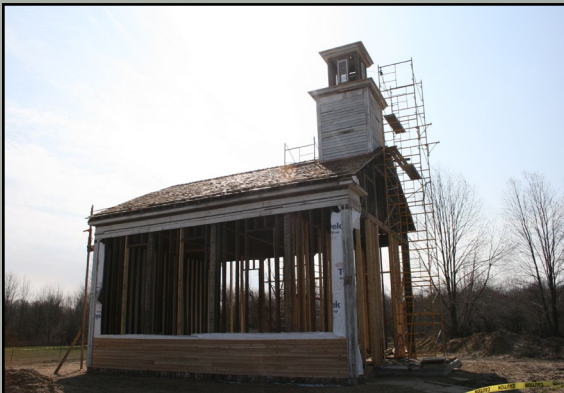
Siding being installed.

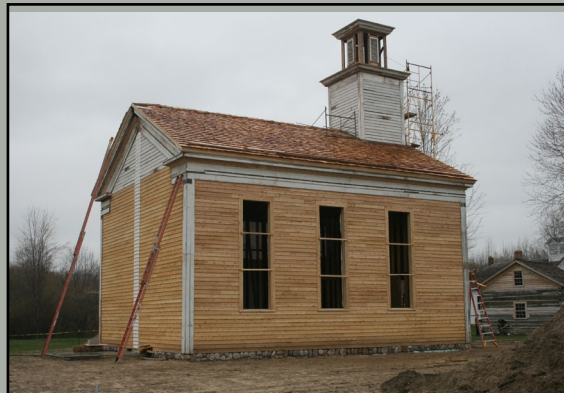
Finishing the exterior work and installing the windows.

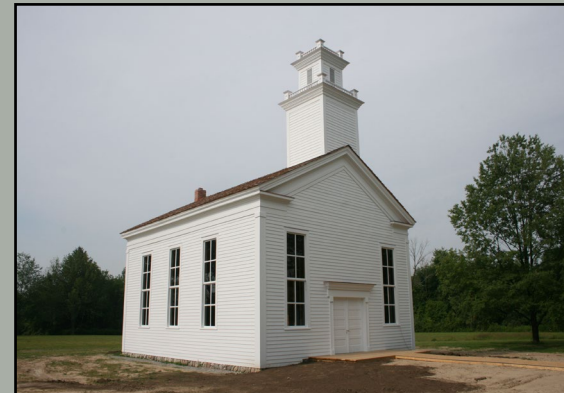
The church painted.
